KANSAS CITY DOWNTOWN AIRPORT – WHEELER FIELD

Comparative Safety Assessment Report

**Kansas City Downtown Airport – Wheeler Field
Kansas City, Missouri**

August 5, 2024

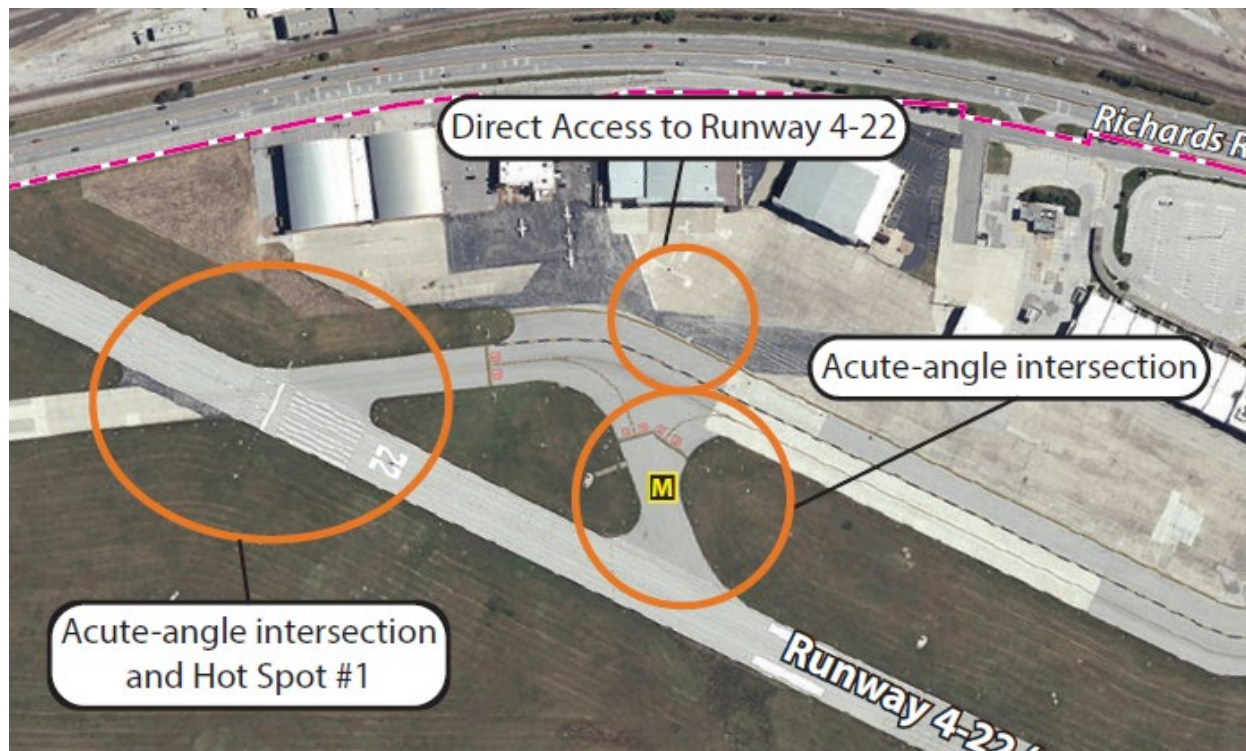
CURRENT CONDITIONS

The Taxiway G and Runway 4-22 intersection is unusual due to the angle of intersection. Wide expanses of pavement at taxiway entrances and taxi paths that provide direct access to a runway can lead to loss of situational awareness for pilots and vehicle operators, which increases the risk of a runway incursion. Taxiway M provides direct access to the Runway from an Apron.

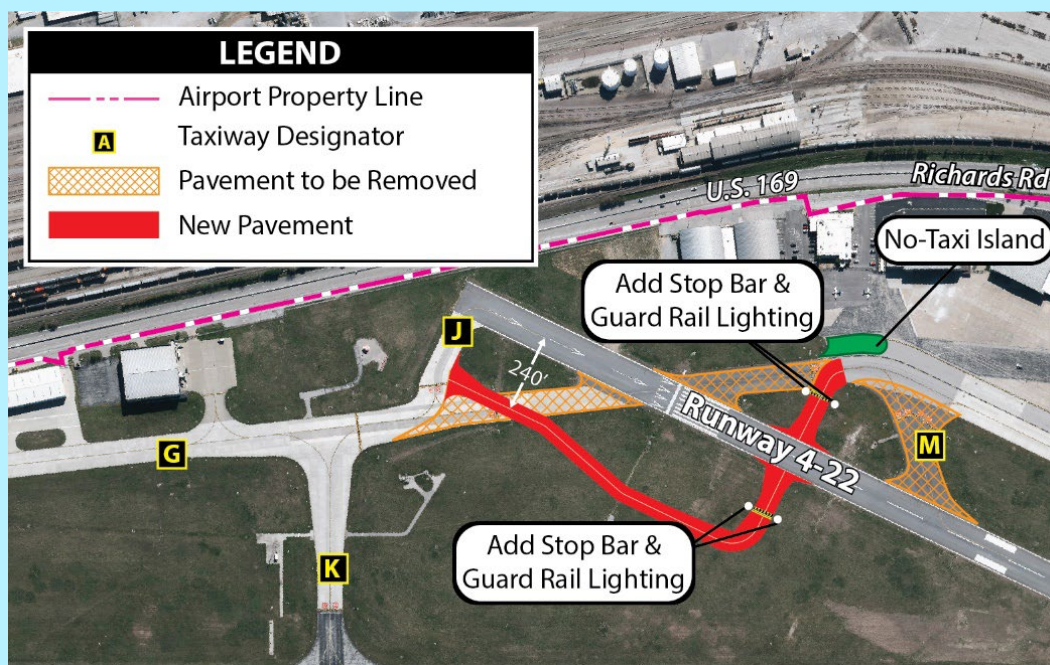
ALTERNATIVE 1

Alternative 1 would remove a portion of Taxiway G that crosses the Runway 22 landing threshold and construct a new right-angle taxiway on either side of Runway 4-22. The new pavement would extend west from the north end of the apron, cross the runway, and turn to the northeast to connect with Taxiway J. Taxiway M would be removed, with the new taxiway connecting the north apron to Runway 22 serving as an exit for pilots landing on Runway 4. A no-taxi island is proposed to force pilots to make a turn prior to entering the runway from the apron to eliminate direct access.

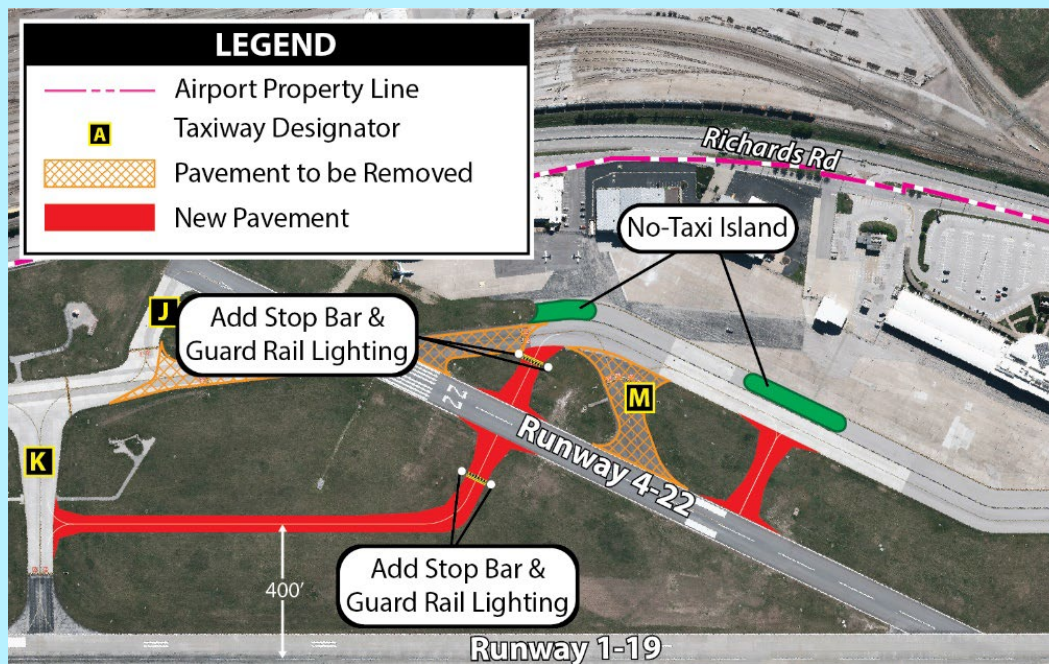
ALTERNATIVE 2

As in Alternative 1, Alternative 2 would remove a portion of Taxiway G pavement that crosses the Runway 22 threshold, and a new right-angle taxiway pavement would be constructed on either side of Runway 4-22. A partial parallel taxiway would be proposed for Runway 1-19. The taxiway would extend from the apron, cross Runway 4-22, and turn north to connect with Taxiway K. Taxiway M would be removed and a new taxiway connector constructed between Taxiway G and Runway 4-22, south of the existing Taxiway M serving as an exit for pilots landing on Runway 4. No-taxi islands are proposed to force pilots to make a turn prior to entering the runway from the apron to eliminate direct access.

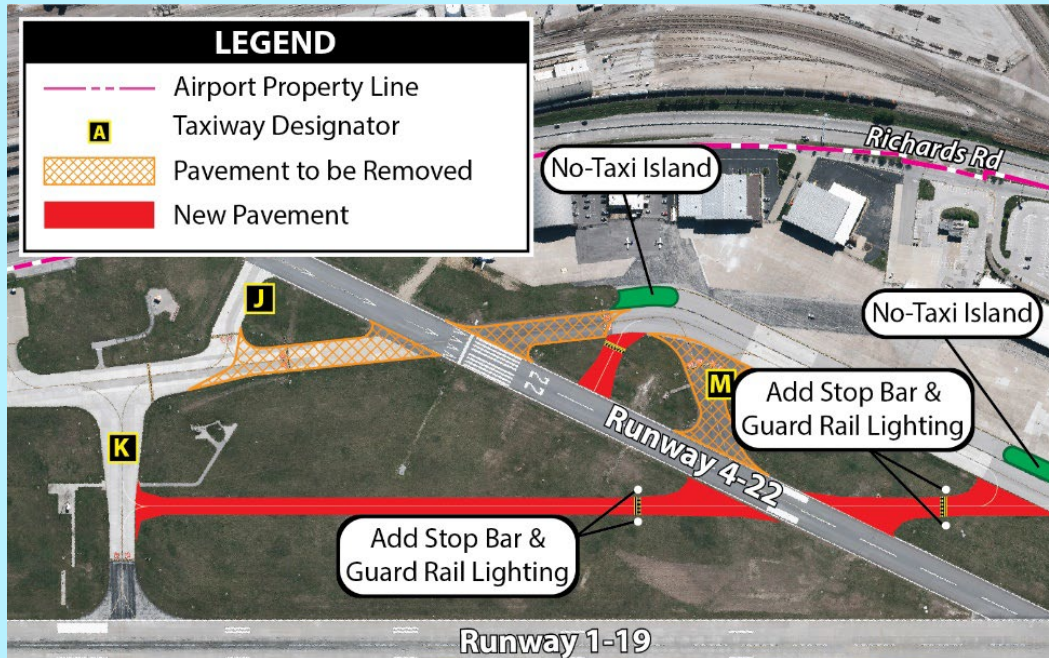
ALTERNATIVE 3

Alternative 3 would remove a portion of Taxiway G pavement that crosses the Runway 22 threshold and new parallel taxiway would be constructed intersecting at Runway 4-22 parallel to Runway 1-19. The new taxiway would extend from Taxiway K to Taxiway G. Taxiway M is proposed to be removed, with a new exit taxiway proposed to extend from the northeast apron to connect with Runway 4-22. No-taxi islands are proposed to force pilots to make a turn prior to entering the runway from the apron to eliminate direct access. Making Taxiway G parallel to Runway 1-19 is a typical geometry that pilots are familiar with.

- The proposed parallel taxiway would cross Runway 4-22 in the high-energy area (middle third of the runway). Per FAA, taxiway crossings through the high energy area are not recommended.
- If a pilot is holding short of the new Taxiway G on either side of Runway 4/-2, pilots will not be perpendicular to the runway.

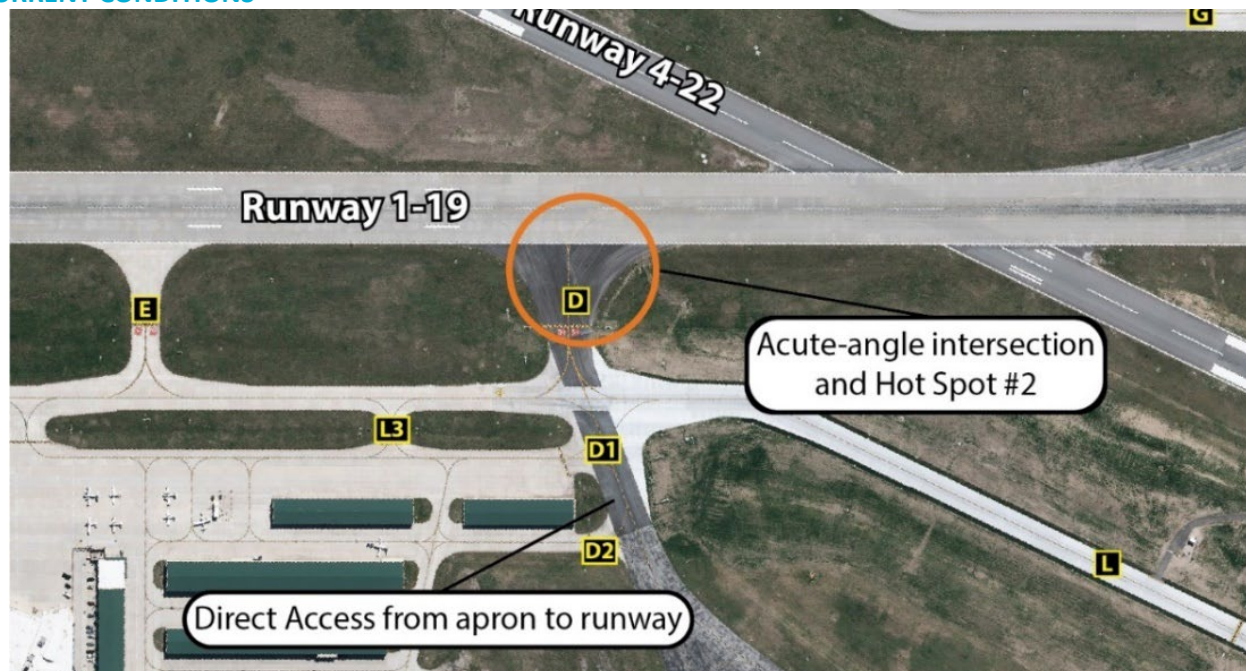
CURRENT CONDITIONS

Taxiway D is an exit taxiway to Runway 1-19. It has been identified as Hot Spot #2 due to past pilot confusion about this intersection. The newly opened extension of Taxiway L is likely to improve pilot situational awareness in this location; however, Taxiway D still provides direct access from an apron area to the runway as it crosses Taxiway L. Removing the direct access issue is the object of the alternatives for this area.

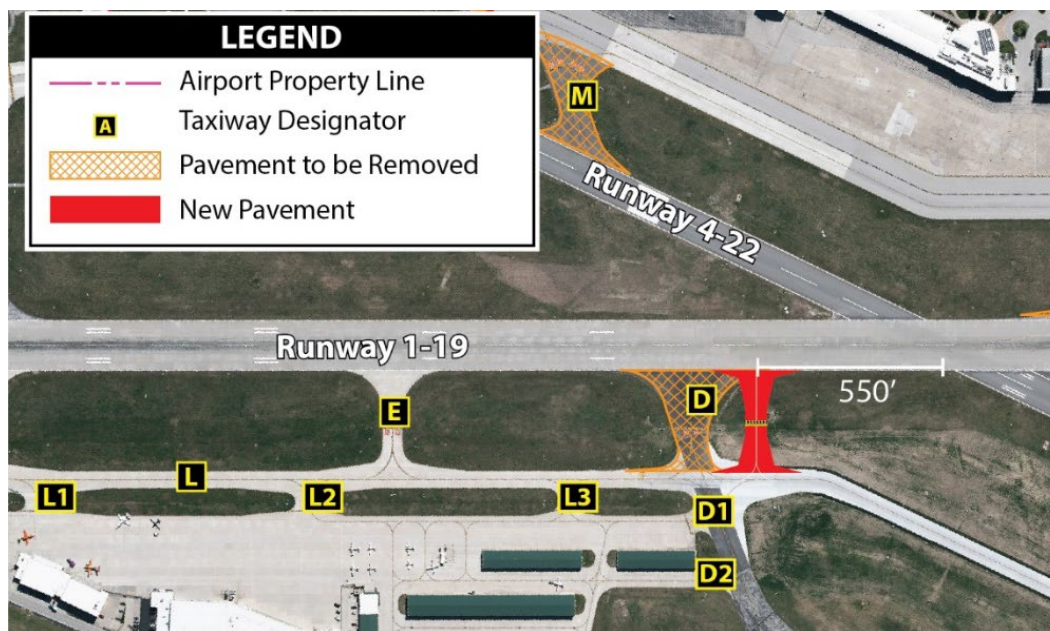
ALTERNATIVE 1

Hotspot #2 is to be alleviated by the closure of a portion of Taxiway D and a replacement connector taxiway approximately 100 feet south of Taxiway D and 550 feet from the runway intersection. A similar option was studied in the past; the primary concern was that a replacement Taxiway D connector closer to the intersection of the two runways might lead to pilot confusion and potential runway incursions. Originally the replacement Taxiway D connector was positioned farther south and thus closer to the intersection of the runway.

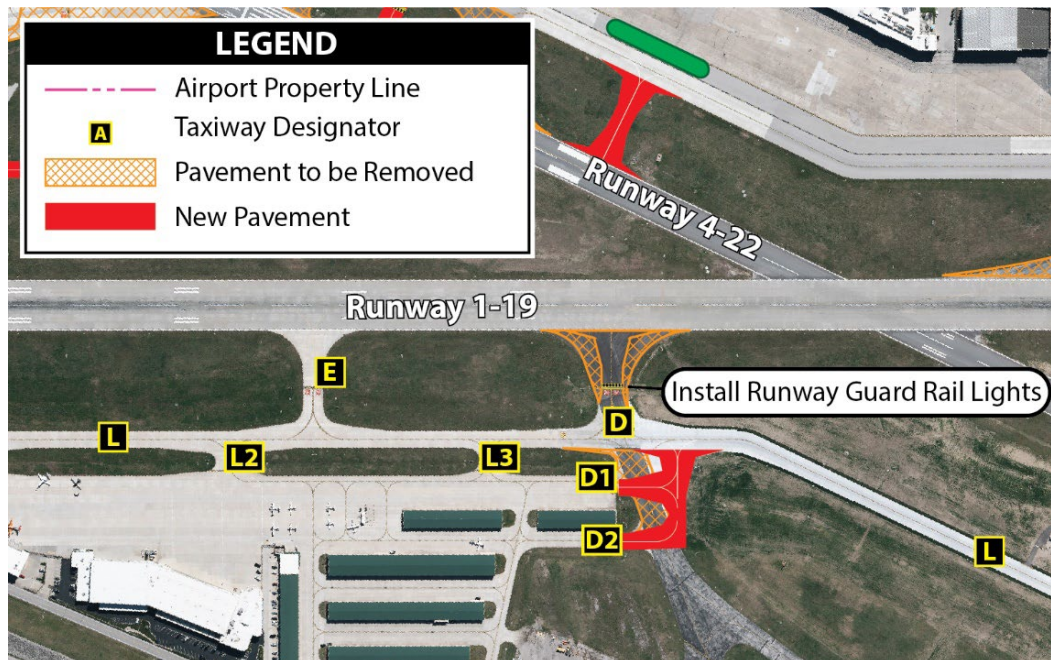
ALTERNATIVE 2

Hotspot #2 is to be alleviated by narrowing Taxiway D to the 50-foot standard, eliminating excess pavement, creating a right-angle connection between the taxiway and runway, and shifting a portion of Taxiway D that is west of Taxiway L, slightly south to eliminate direct access to the runway thus creating a 90-degree intersection with Taxiway L. To further reduce the risk of accidental entrance onto Runway 1-19, runway guard lights are proposed to enhance the visibility of the taxiway/runway intersection.

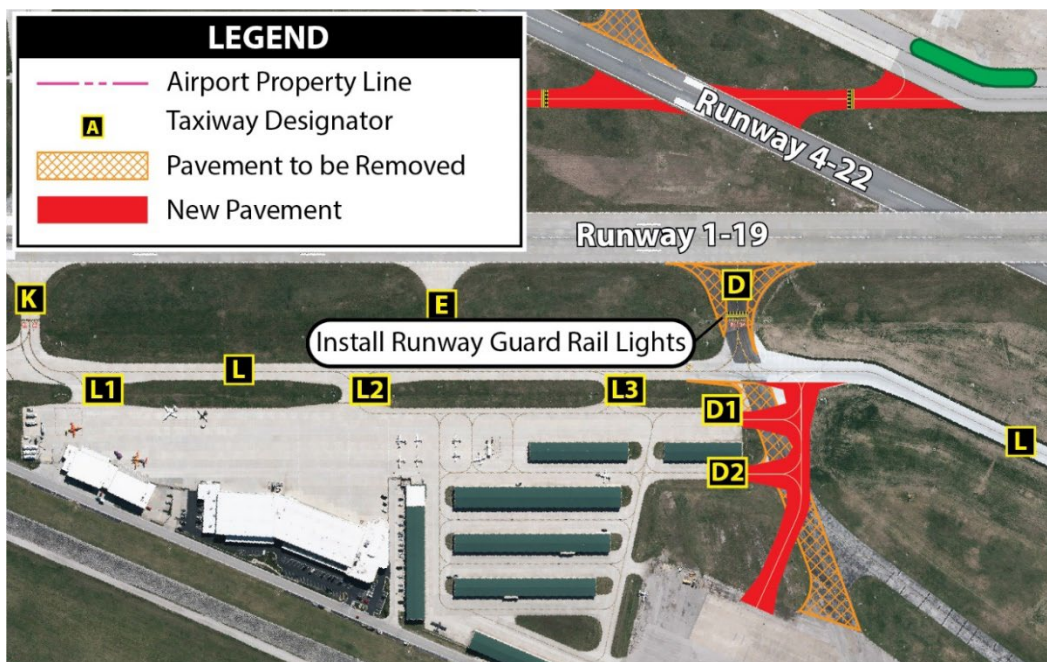
ALTERNATIVE 3

Hotspot #2 is to be mitigated in a manner similar to Alternative 2. Taxiway D is narrowed to provide a 50-foot-wide surface and right-angle connection to Runway 1-19. The western portion of Taxiway D that extends from Taxiway L to the west apron is proposed to be configured to provide an offset connection to Taxiway L. The west portion of Taxiway D then angles slightly to the north to maximize the developable area to the south.

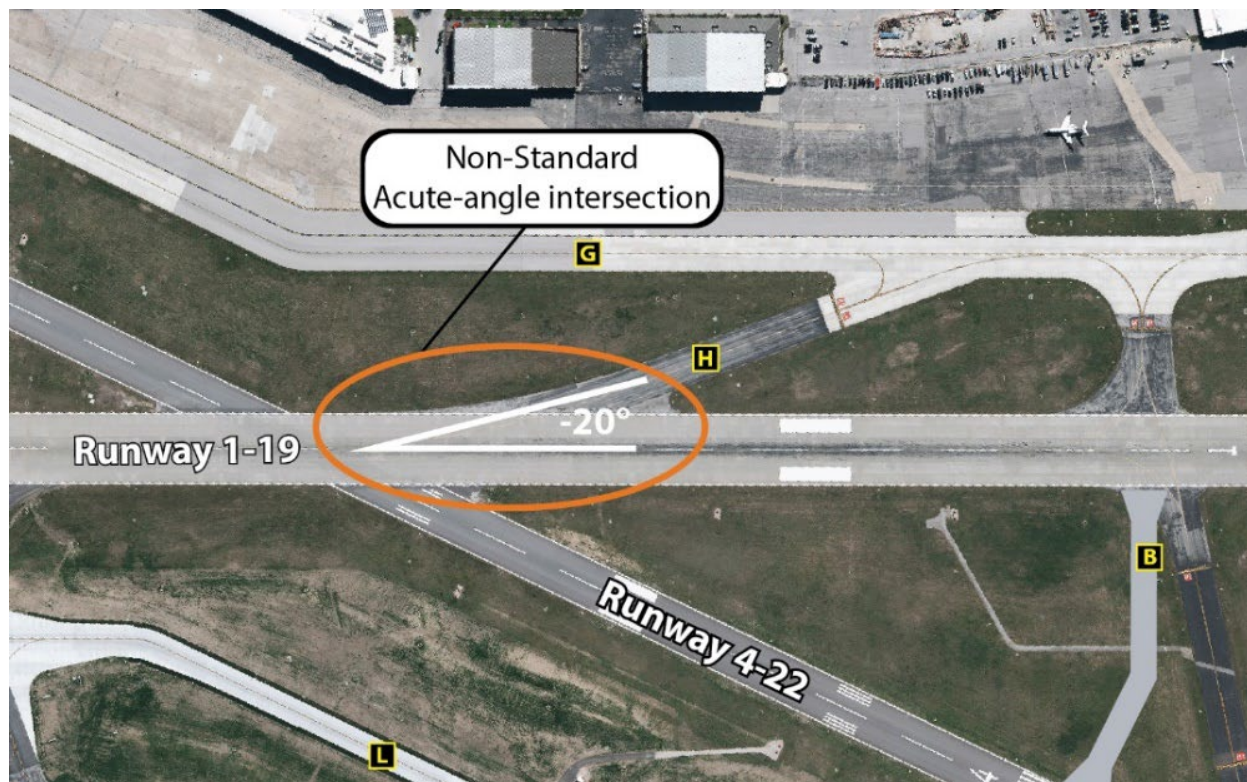
CURRENT CONDITION

Taxiway H currently provides a quick exit from the runway for aircraft landing on Runway 19. The preferred geometry for exit taxiways is 90 degrees for pilots to have full peripheral views. At capacity-constrained airports (like MKC), angled taxiways are permissible; however, there are geometric standards for the angle that would apply. The existing Taxiway H is a high-speed exit; however, it is not currently at a standard angle.

FAA taxiway geometry standards recommend that taxiways be positioned 90 degrees to intersecting taxiways and runways to provide pilots full peripheral views. Acute-angled intersections are permissible when constructed to standard angles and when needed for capacity improvement purposes. Acute angled taxiways are present at MKC on Taxiways D, G, H, and M. This element addresses Taxiway H which is at a 20-degree angle to the runway.

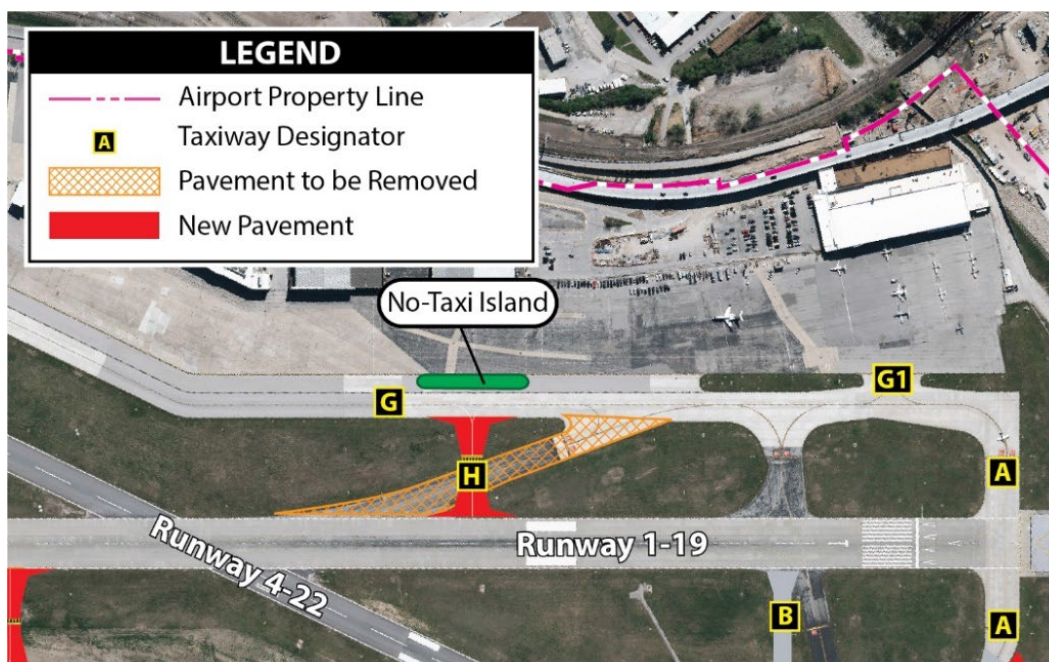
ALTERNATIVES 1 & 2

In this alternative, existing Taxiway H pavement is proposed to be removed and a new right-angle connector would be constructed between Runway 1-19 and Taxiway G. Note that alternatives 1 and 2 are the same in the master plan, therefore the pros and cons apply to both.

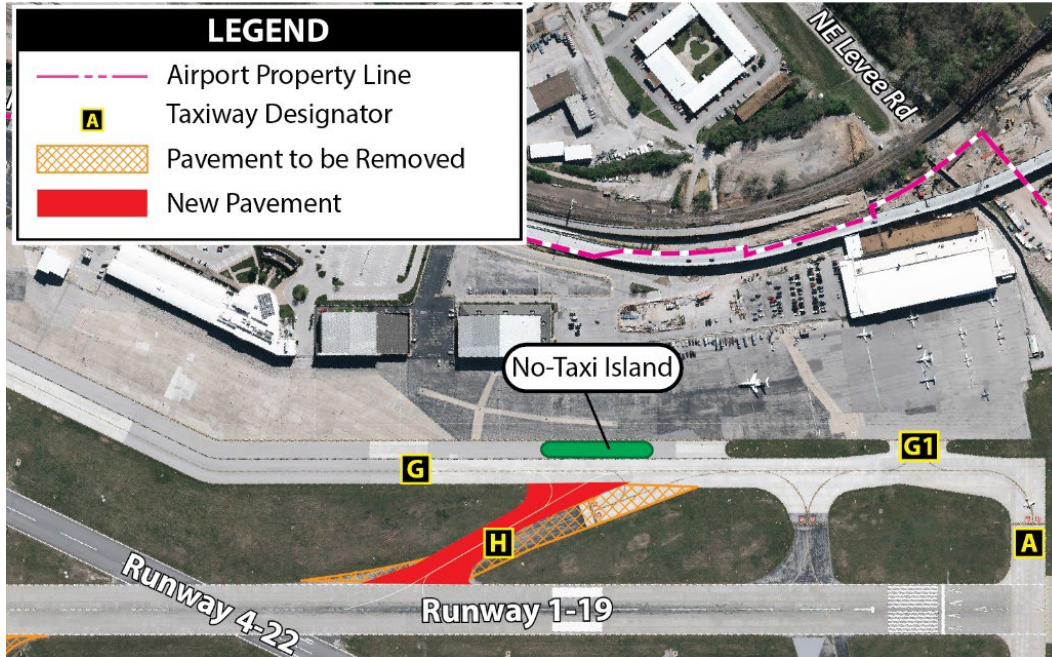
ALTERNATIVE 3

When it is time for Taxiway H to be reconstructed due to normal use, Taxiway H would be reconstructed at the standard 30-degree angle.

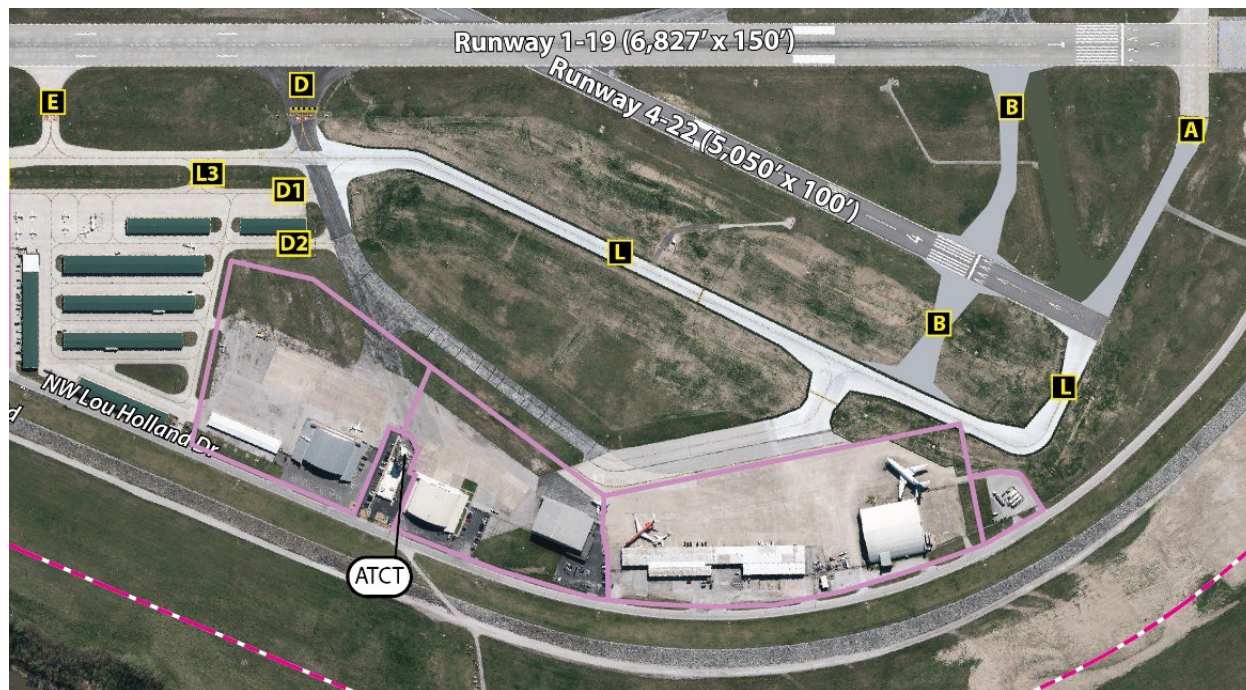
CURRENT CONDITIONS

The analysis for the southwest landside options is based on the current ATCT location to determine if proposed alternatives would interfere with the tower controller's line of sight. Each analysis is based on a cab eye level of 72 feet, with assumed hangar heights ranging from 20 feet (T-hangar) to 65 feet (a 200-foot by 200-foot conventional hangar).

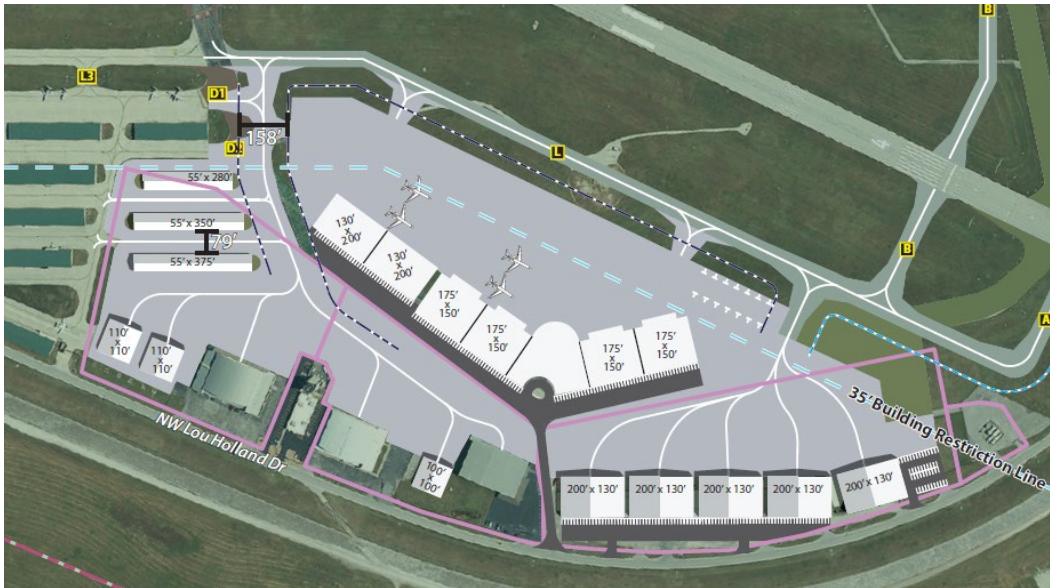
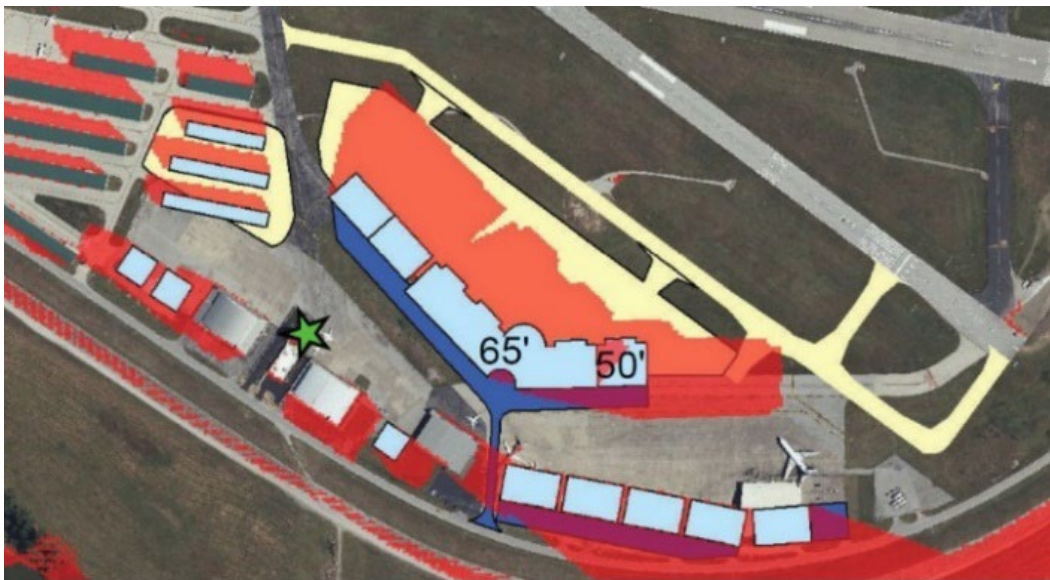
ALTERNATIVE 4

- The parking lot extends along the west edge of the lease line before the hangars. This layout locates the hangars as far back to the west as possible to maximize control tower sightlines.
- The access road is extended from Lou Holland Drive adjacent to Hangar 8B. This location is along the current lease line, which limits separating facilities.

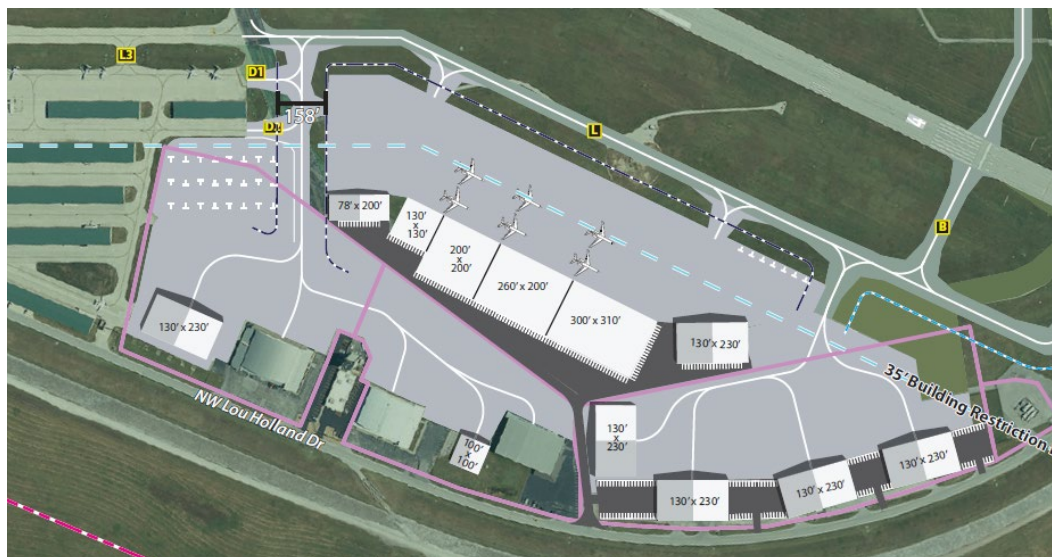
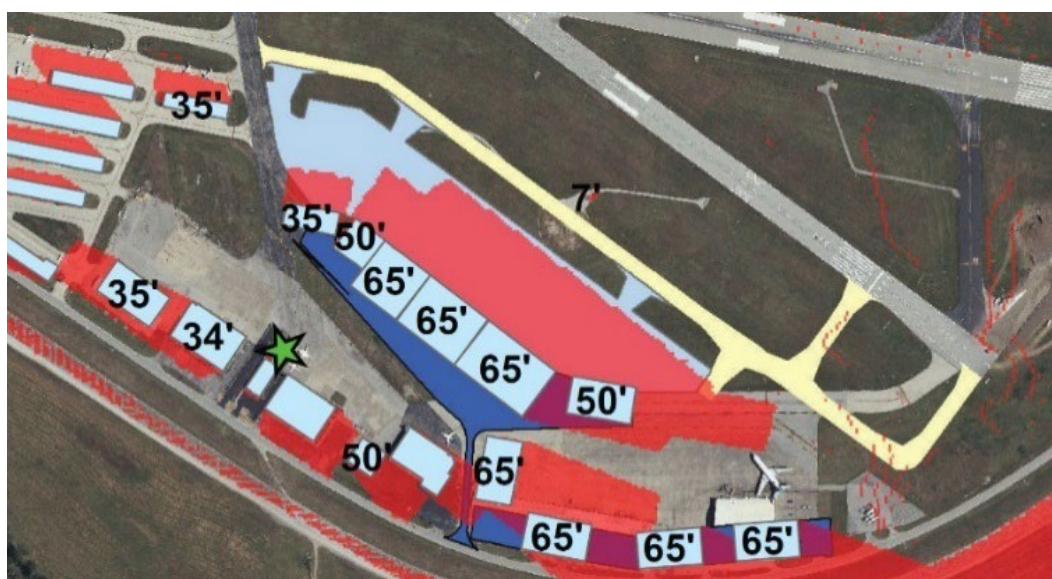
ALTERNATIVE 5

- This layout locates the hangars as far back to the west as possible to maximize control tower sightlines.
- The entirety of Taxiway L and the TOFA are visible to ATC staff providing a clear line of sight and no constraints.

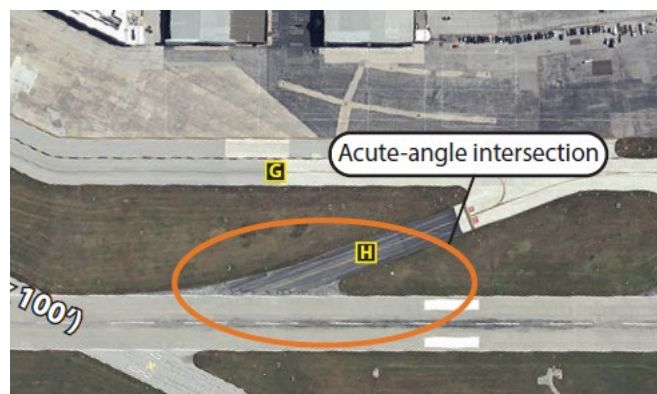
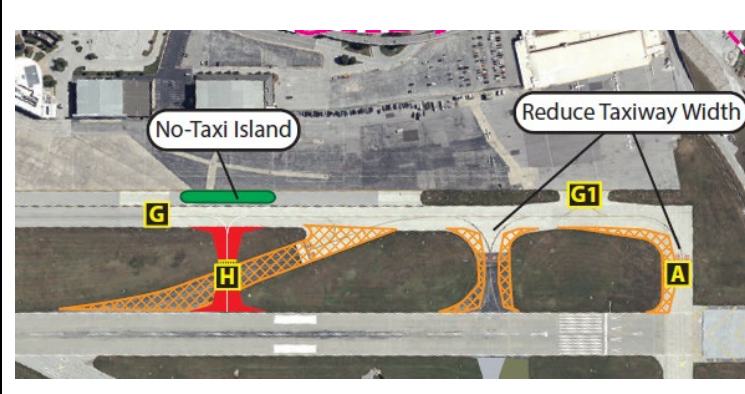
Element	Brief Description	Safety Concern	Alternative 1	Alternative 2	Alternative 3
Taxiway H – High-Speed Exit	<p>Taxiway H currently provides a quick exit from the runway for aircraft landing on Runway 19. The preferred geometry for exit taxiways is 90 degrees for pilots to have full peripheral views.</p> <p>At capacity-constrained airports (like MKC), angled taxiways are permissible; however, there are geometric standards for the angle that would apply. The existing Taxiway H is a high-speed exit; however, it is not at a standard angle.</p>	<p>Acute-angle intersection.</p> <p>The angle between the runway centerline and the Taxiway H centerline is currently 20 degrees.</p> <p>According to FAA Advisory Circular (AC) 150/5300-13B, Airport Design, the standard angle for a high-speed exit is 30 degrees.</p>	<p>a) In this alternative, existing Taxiway H pavement is proposed to be removed and a new right-angle connector constructed between Runway 1-19 and Taxiway G.</p> <p>b) This alternative also proposes two no-taxi islands, which are areas of either natural turf or artificial turf/paint that force pilots to make a turn prior to entering the runway environment, thereby improving pilot situational awareness, and reducing the risk of a runway incursion.</p> <p>c) No-taxi islands are proposed near the to eliminate apron to runway direct access.</p>	<p>a) Like the previous taxiway alternative, a similar modification is proposed for Taxiway H.</p> <p>b) Existing Taxiway H pavement is proposed to be removed and a new right-angle connector constructed between Runway 1-19 and Taxiway G.</p> <p>c) No-taxi islands are proposed near the to eliminate apron to runway direct access.</p>	<p>a) Taxiway H is proposed to remain as a high-speed exit taxiway because it enhances runway capacity by reducing runway occupancy times.</p> <p>b) This high-speed taxiway exit is also highly utilized, according to the airport traffic control tower (ATCT) manager, who indicated they would prefer to keep it operational as a high-speed exit.</p> <p>c) When it is time for Taxiway H to be reconstructed due to normal use, it is shown in a slightly different configuration.</p> <p>d) The angle between the runway centerline and the Taxiway H centerline is currently 20 degrees. According to the FAA AC 150/5300-13B, the standard angle for a high-speed exit is 30 degrees; therefore, this alternative shows Taxiway H to be reconstructed at the standard 30-degree angle.</p> <p>e) Another consideration is the capability for a reverse turn onto the parallel taxiway. The recommended runway-to-taxiway separation to allow for a reverse turn is 350 feet for a critical aircraft in taxiway design group (TDG) 3.</p> <p>f) The future TDG for the airport is TDG 3, and the current runway-to-taxiway separation is 412.5 feet; therefore, a high-speed exit with a reverse turn onto the parallel taxiway is feasible.</p> <p>g) No-taxi islands are proposed near the to eliminate apron to runway direct access.</p>

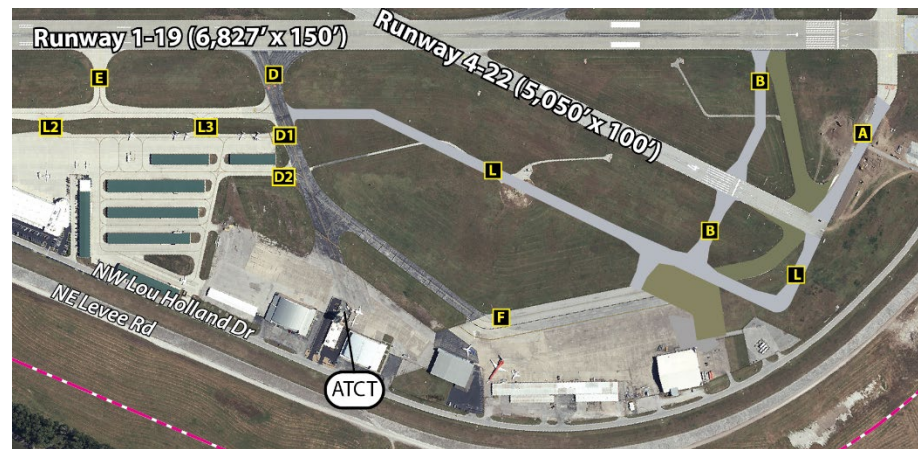
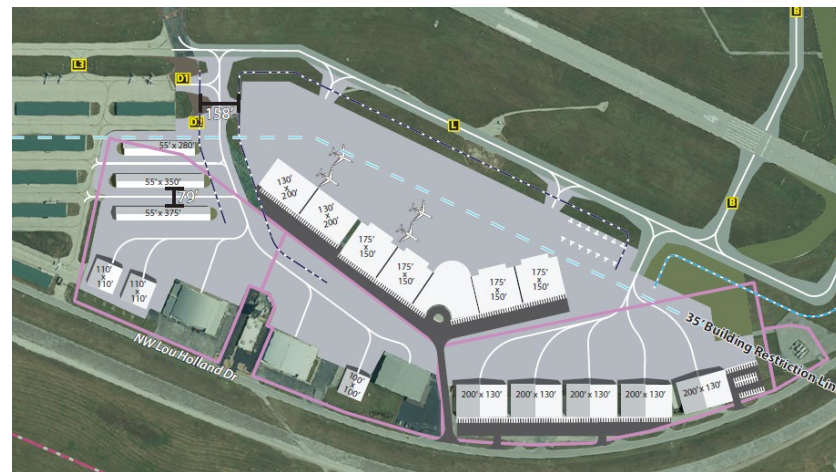
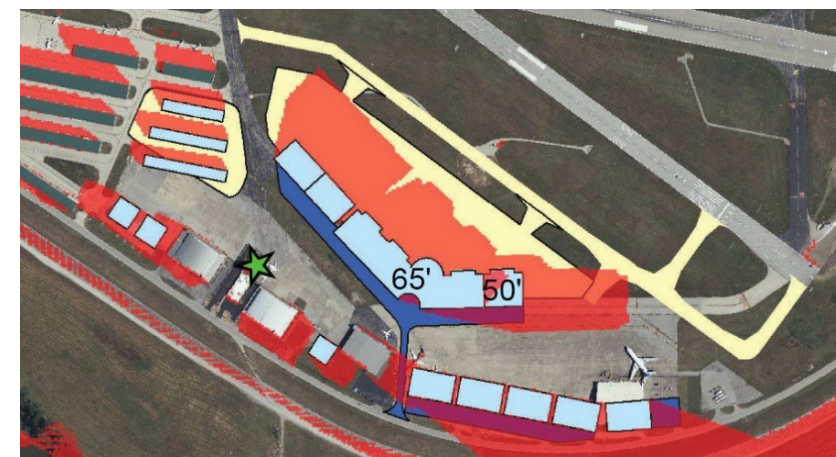
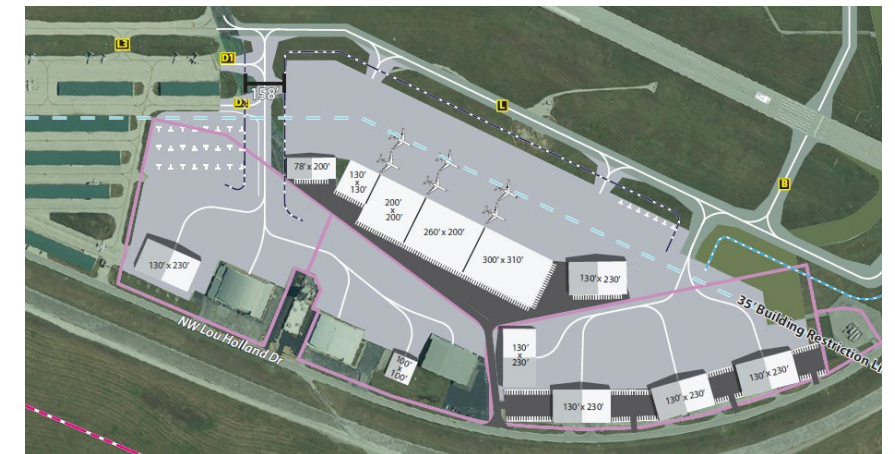
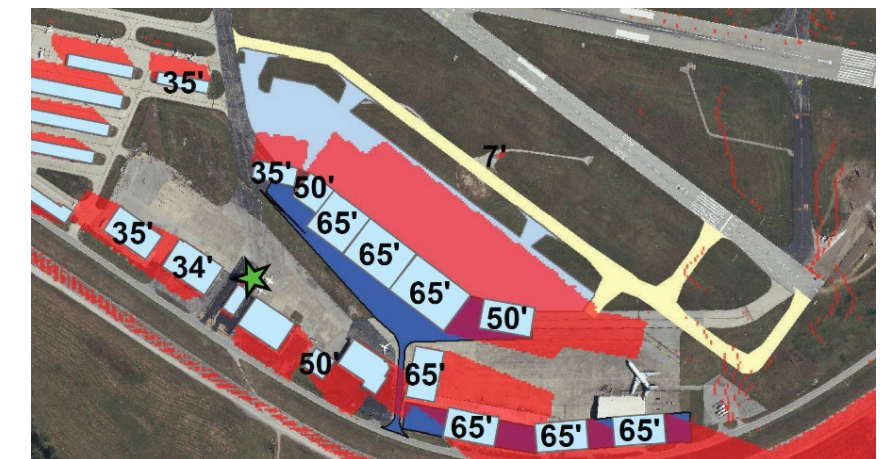
Element	Brief Description	Safety Concern(s)	Alternative 4	Alternative 5
Southwest Landside Alternatives Constrained by Existing Lease Lines	<p>This analysis is based on the current ATCT location to determine if the alternatives would interfere with the tower controller's line of sight.</p> <p>Each analysis is based on a cab eye level of 72 feet, with assumed hangar heights ranging from 20 feet (T-hangar) to 65 feet (200-foot by 200-foot conventional hangar).</p>	<p>Areas shaded in red are locations that would not be visible from the cab to the ground. The viewshed analysis for each southwest landside alternative is shown in the second figure of each alternative.</p> <p>Additionally, the existing Taxiway F will no longer serve as a taxiway under FAA ATCT control and will be separated by a roadway that enters the area from Lou Holland Drive.</p>	<ol style="list-style-type: none"> This is the first of two alternatives that generally preserve the existing lease lines in the southwest quadrant. This alternative considers several large conventional hangars that might be typical of an FBO complex. The hangars are large enough to house the largest business jets and potentially larger commercial type aircraft used for charter purposes. An access road is extended from Lou Holland Drive adjacent to Hangar 8B. This location is along the current lease line, which limits separating facilities. The access road extends to the 26-acre parcel that is currently unleased. The parking lot extends along the west edge of the lease line before the hangars. This layout attempts to locate the hangars as far back to the west as possible to maximize control tower sightlines. This alternative shows additional hangar development on parcels that are currently leased. Additional T-hangars are shown in proximity to the existing T-hangars. The existing shade hangar is shown to be replaced with two medium-sized box hangars. The south area is shown to be completely redeveloped with a series of conventional hangars. 	<ol style="list-style-type: none"> This is a variation of Landside Alternative 4 in which the centrally located hangars are more linearly oriented. There are a variety of hangar sizes; however, all are larger hangars that are typical for FBO services, bulk storage, or maintenance activities. The access road extends adjacent to Hangar 8B again along the existing parcel line. A development scenario is also shown for those areas that are currently under lease. On the south side of the new access road is redevelopment with four large conventional hangars. On the north side of the access road, the shade hangar is replaced with a conventional hangar and one other box hangar is shown to fill in an undeveloped area next to the AirShare hangar. The area next to the existing T-hangars is shown with a tiedown apron.

- Alternatives #1, #2, and #3 were not considered due to participant consensus that existing lease lines were to be maintained.
- Line of sight (viewshed review) was the most critical decision factor for alternative selection.
- Loss of Taxiway F as the primary taxi route into the area is managed by the implementation of Taxiway L as a replacement alternative.
- Segregating the development area with a roadway is required to provide access to the new facilities.
- Preserving existing lease lines will allow for existing facilities to maintain operations in a single area.
- In Alternative #4, Taxiway L is visible but small portions of the taxiway object free area (TOFA) would be blocked. The height of the proposed hangars could be lowered to make the entire TOFA visible; however, Alternative #5 does not require modifications and thus is a better alternative.
