KANSAS CITY WHEELER DOWNTOWN AIRPORT

FINAL COMPARATIVE SAFETY ASSESSMENT

**Kansas City Wheeler Downtown Airport
Kansas City, Missouri**

Appendix F Comparative Safety Assessment

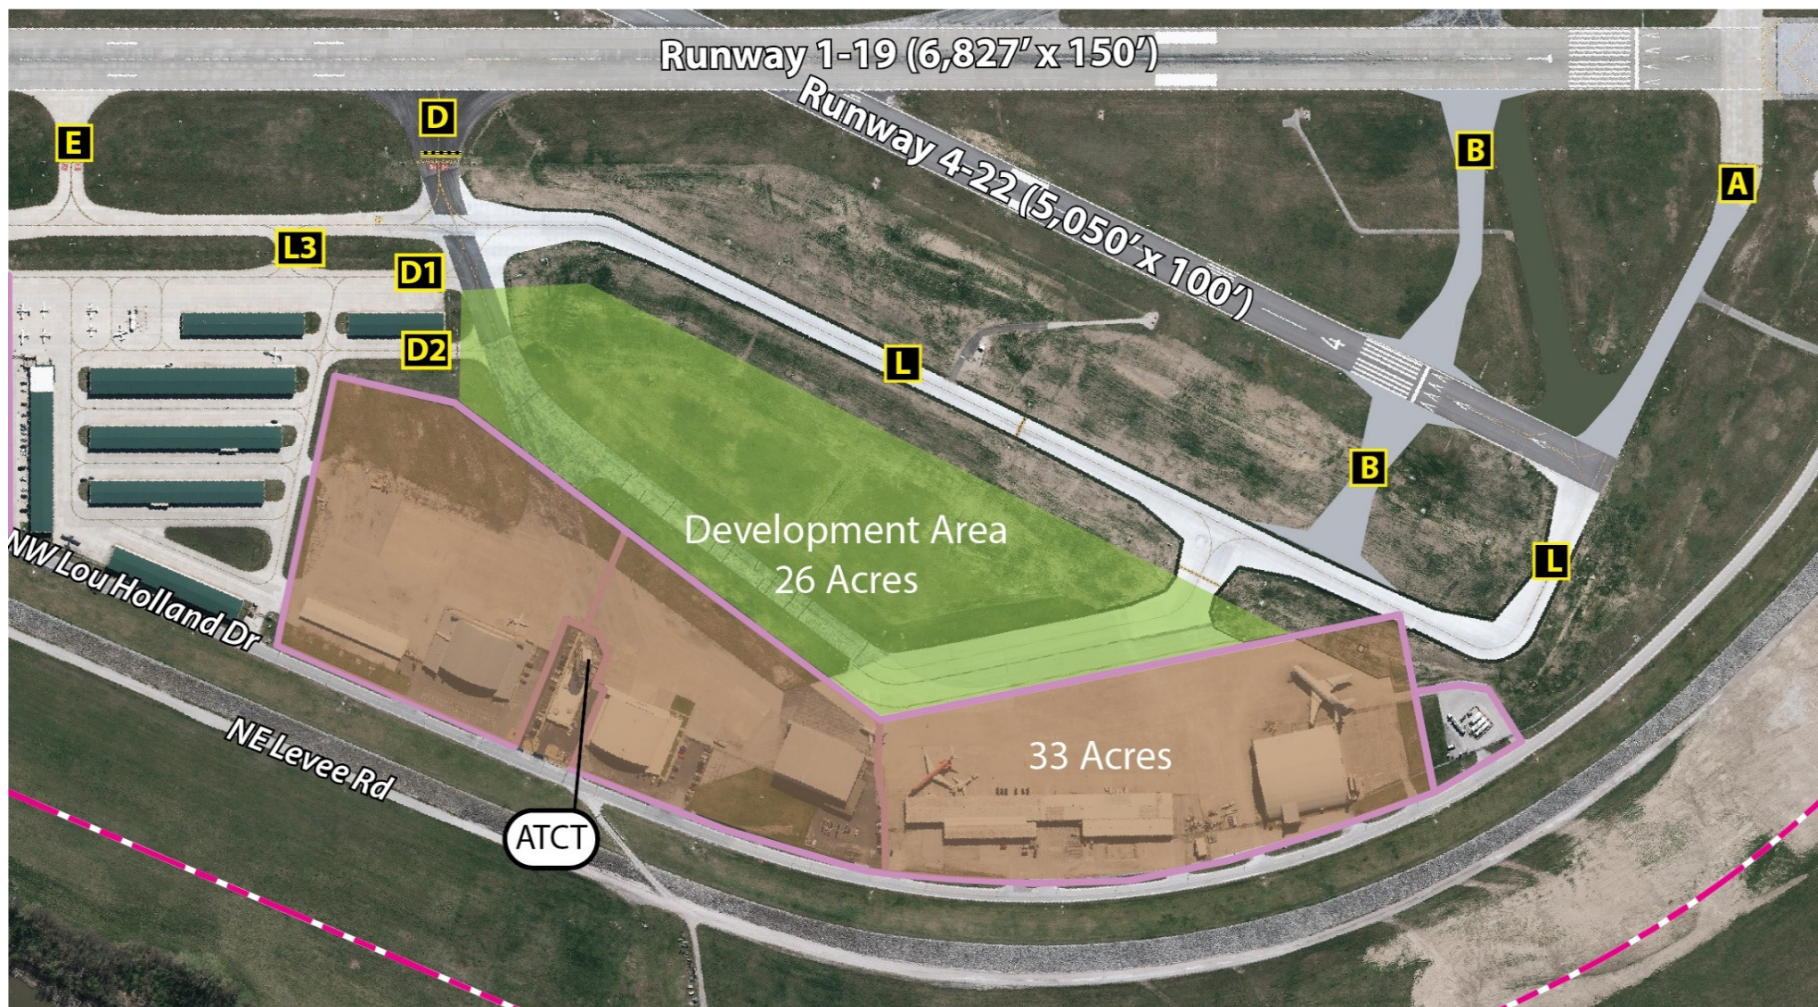
Figure 4 – Airfield Development Location

Element 4: Taxiway L – Southwest Development Area: With the successful completion of the Taxiway L extension, the southwest quadrant of the airport now has land available for aeronautical development. The entire southwest area is approximately 59 acres (includes taxilanes) and the area that is not currently under lease is 26 acres (includes taxilanes). The first three alternatives assume no constraints because of the existing lease lines. The last two alternatives plan for new hangars around the existing lease lines, assuming the unleased area can be developed first and independent of other areas currently under leases. See **Figure 4** for the Southwest Development Area current state.

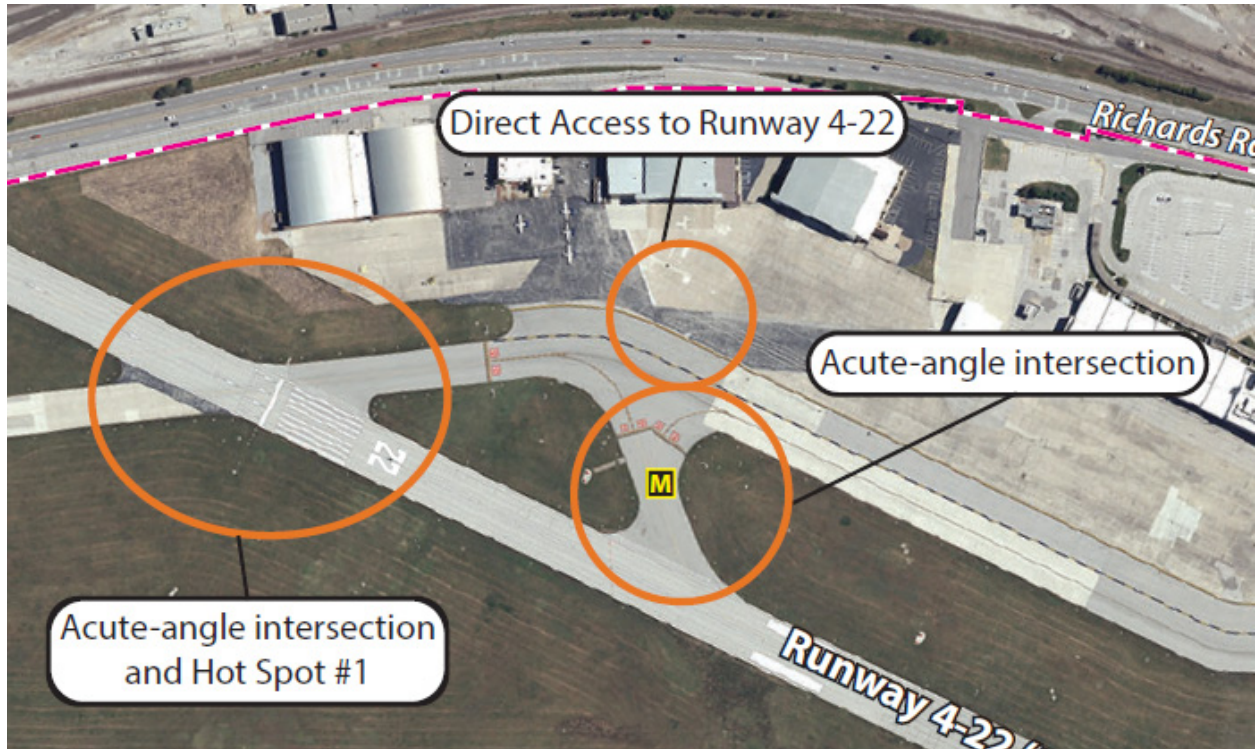
CURRENT CONDITIONS

The Taxiway G and Runway 4-22 intersection is unusual due to the angle of intersection. Wide expanses of pavement at taxiway entrances and taxi paths that provide direct access to a runway can lead to loss of situational awareness for pilots and vehicle operators, which increases the risk of a runway incursion. Taxiway M provides direct access to the Runway from an Apron.

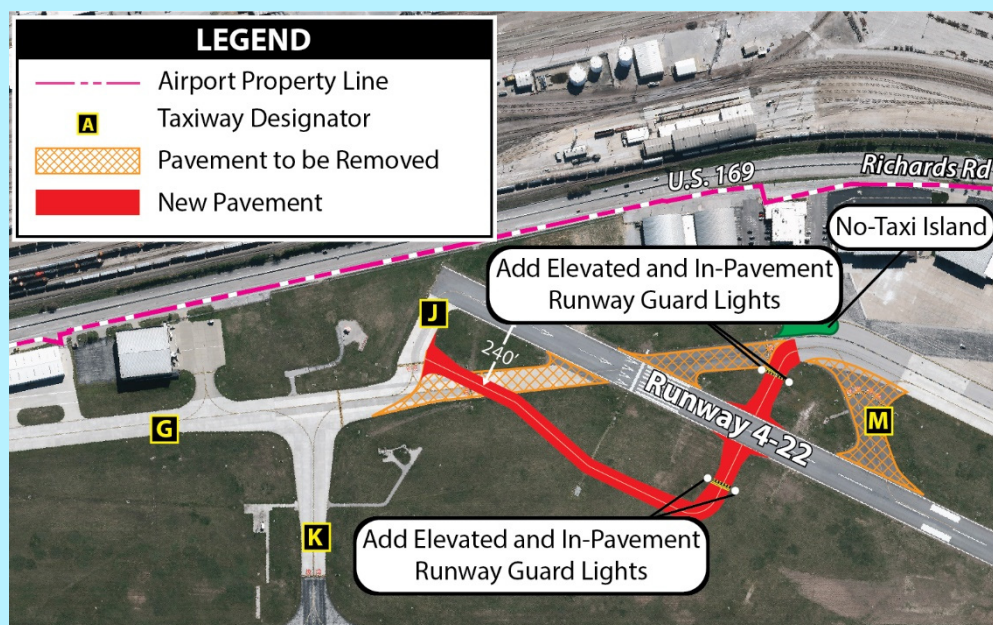
ALTERNATIVE 1

Alternative 1 would remove a portion of Taxiway G that crosses the Runway 22 landing threshold and construct a new right-angle taxiway on either side of Runway 4-22. The new pavement would extend west from the north end of the apron, cross the runway, and turn to the northeast to connect with Taxiway J. Taxiway M would be removed, with the new taxiway connecting the north apron to Runway 22 serving as an exit for pilots landing on Runway 4. A no-taxi island is proposed to force pilots to make a turn prior to entering the runway from the apron to eliminate direct access.

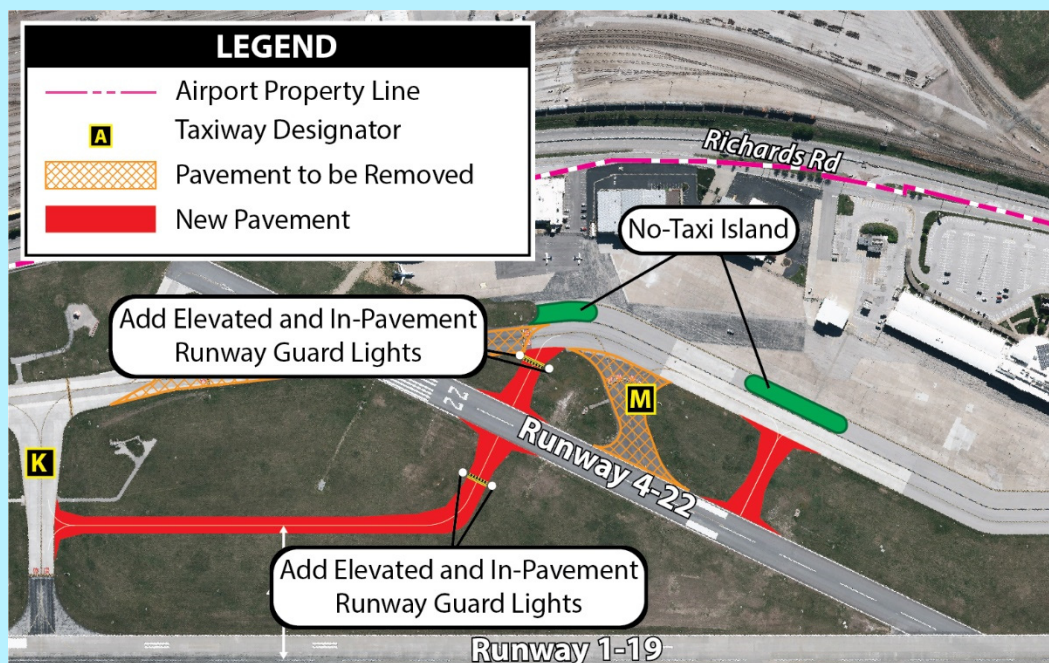
ALTERNATIVE 2

As in Alternative 1, Alternative 2 would remove a portion of Taxiway G pavement that crosses the Runway 22 threshold, and a new right-angle taxiway pavement would be constructed on either side of Runway 4-22. A partial parallel taxiway would be proposed for Runway 1-19. The taxiway would extend from the apron, cross Runway 4-22, and turn north to connect with Taxiway K. Taxiway M would be removed and a new taxiway connector constructed between Taxiway G and Runway 4-22, south of the existing Taxiway M serving as an exit for pilots landing on Runway 4. No-taxi islands are proposed to force pilots to make a turn prior to entering the runway from the apron to eliminate direct access.

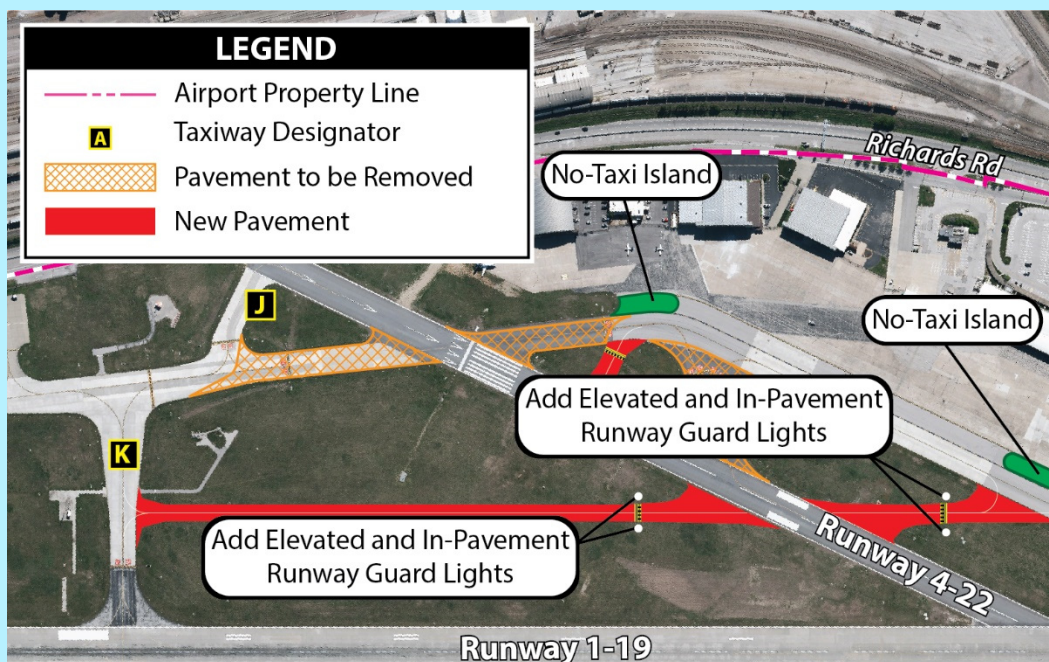
ALTERNATIVE 3

Alternative 3 would remove a portion of Taxiway G pavement that crosses the Runway 22 threshold and new parallel taxiway would be constructed intersecting at Runway 4-22 parallel to Runway 1-19. The new taxiway would extend from Taxiway K to Taxiway G. Taxiway M is proposed to be removed, with a new exit taxiway proposed to extend from the northeast apron to connect with Runway 4-22. No-taxi islands are proposed to force pilots to make a turn prior to entering the runway from the apron to eliminate direct access. Making Taxiway G parallel to Runway 1-19 is a typical geometry that pilots are familiar with.

- The proposed parallel taxiway would cross Runway 4-22 in the high-energy area (middle third of the runway). Per FAA, taxiway crossings through the high energy area are not recommended.
- If a pilot is holding short of the new Taxiway G on either side of Runway 4-22, pilots will not be perpendicular to the runway.
- The intersection of Taxiway K and the new Taxiway G may be a choke point as there may not be sufficient spacing or clearance if an aircraft exited Runway 1-19 onto Taxiway K and was stopped after crossing the hold bar. Larger business jets might not be able to maneuver past the holding aircraft when taxiing south using Taxiway K to access the new Taxiway G.

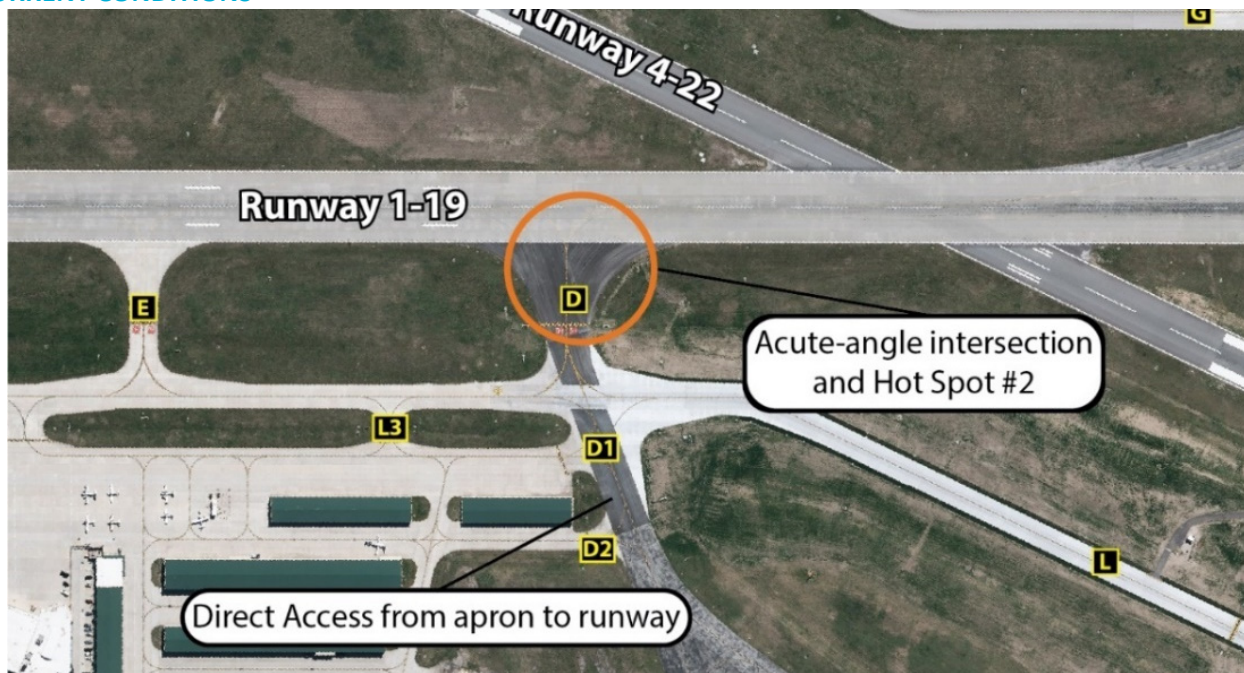
CURRENT CONDITIONS

Taxiway D is an exit taxiway to Runway 1-19. It has been identified as Hot Spot #2 due to past pilot confusion about this intersection. The newly opened extension of Taxiway L is likely to improve pilot situational awareness in this location; however, Taxiway D still provides direct access from an apron area to the runway as it crosses Taxiway L. Removing the direct access issue is the object of the alternatives for this area.

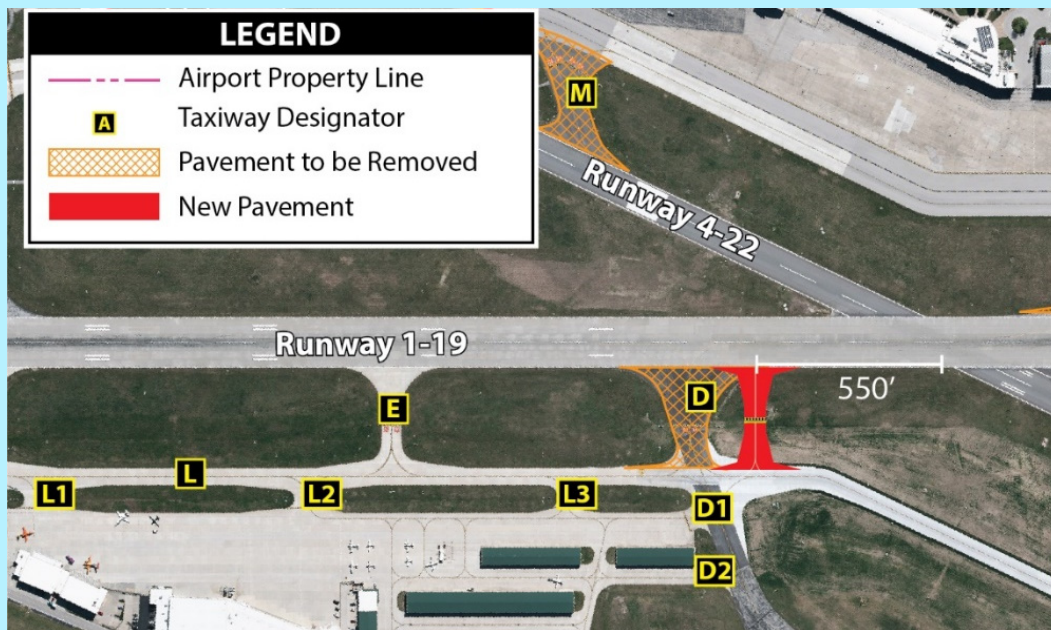
ALTERNATIVE 1

Hotspot #2 is to be alleviated by the closure of a portion of Taxiway D and a replacement connector taxiway approximately 100 feet south of Taxiway D and 550 feet from the runway intersection. A similar option was studied in the past; the primary concern was that a replacement Taxiway D connector closer to the intersection of the two runways might lead to pilot confusion and potential runway incursions. Originally the replacement Taxiway D connector was positioned farther south and thus closer to the intersection of the runway.

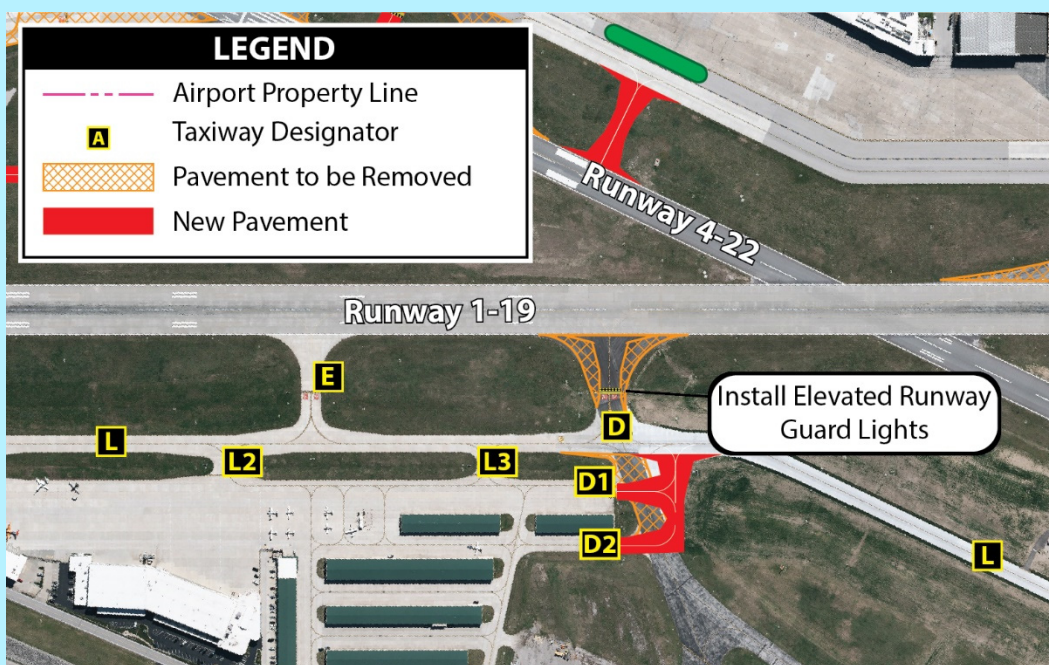
ALTERNATIVE 2

Hotspot #2 is to be alleviated by narrowing Taxiway D to the 50-foot standard, eliminating excess pavement, creating a right-angle connection between the taxiway and runway, and shifting a portion of Taxiway D that is west of Taxiway L, slightly south to eliminate direct access to the runway thus creating a 90-degree intersection with Taxiway L. To further reduce the risk of accidental entrance onto Runway 1-19, runway guard lights are proposed to enhance the visibility of the taxiway/runway intersection.

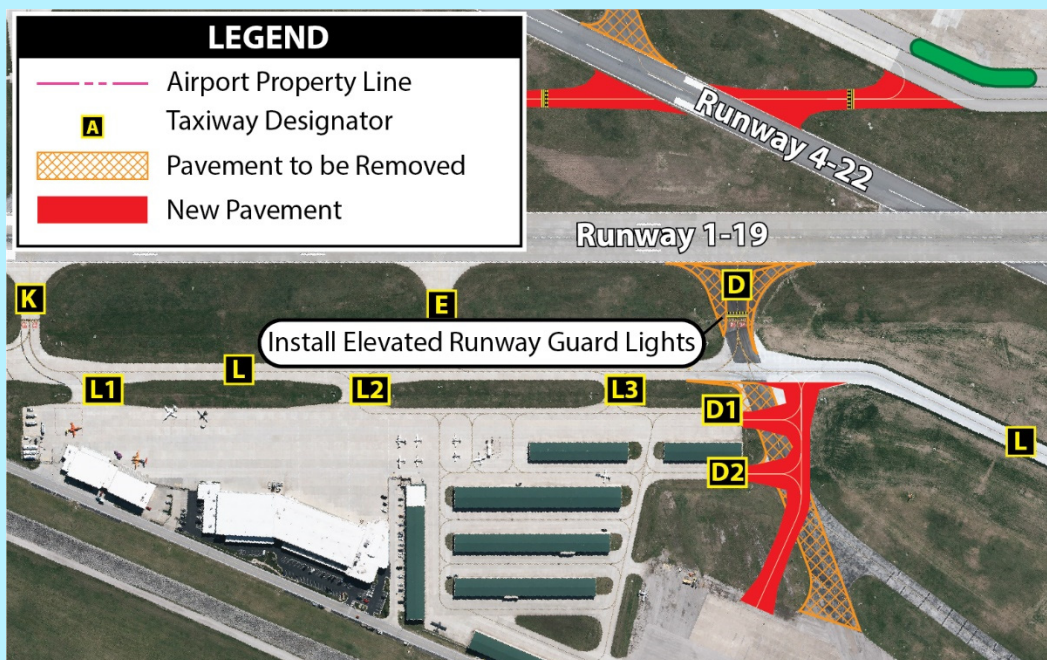
ALTERNATIVE 3

Hotspot #2 is to be mitigated in a manner similar to Alternative 2. Taxiway D is narrowed to provide a 50-foot-wide surface and right-angle connection to Runway 1-19. The western portion of Taxiway D that extends from Taxiway L to the west apron is proposed to be configured to provide an offset connection to Taxiway L. The west portion of Taxiway D then angles slightly to the north to maximize the developable area to the south.

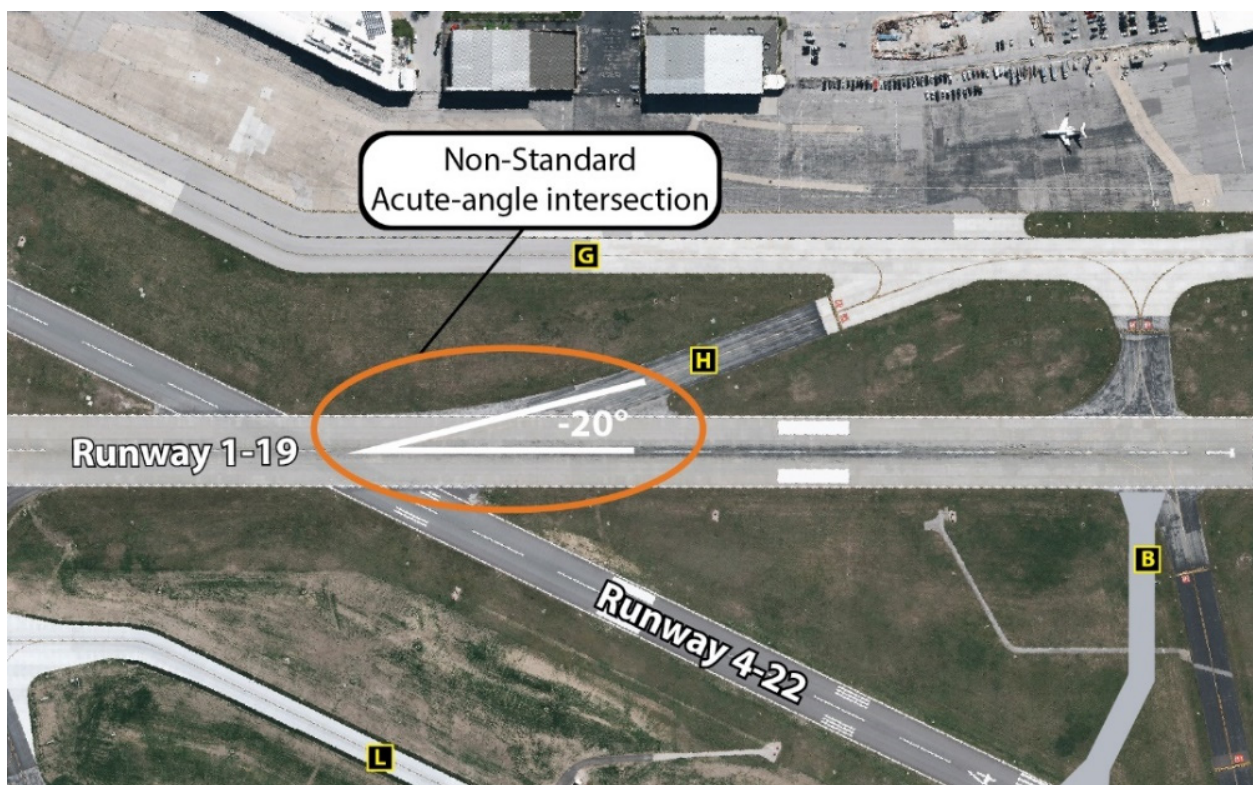
CURRENT CONDITION

Taxiway H currently provides a quick exit from the runway for aircraft landing on Runway 19. The preferred geometry for exit taxiways is 90 degrees for pilots to have full peripheral views. At capacity-constrained airports (like MKC), angled taxiways are permissible; however, there are geometric standards for the angle that would apply. The existing Taxiway H is a high-speed exit; however, it is not currently at a standard angle.

FAA taxiway geometry standards recommend that taxiways be positioned 90 degrees to intersecting taxiways and runways to provide pilots full peripheral views. Acute-angled intersections are permissible when constructed to standard angles and when needed for capacity improvement purposes. Acute angled taxiways are present at MKC on Taxiways D, G, H, and M. This element addresses Taxiway H which is at a 20-degree angle to the runway.

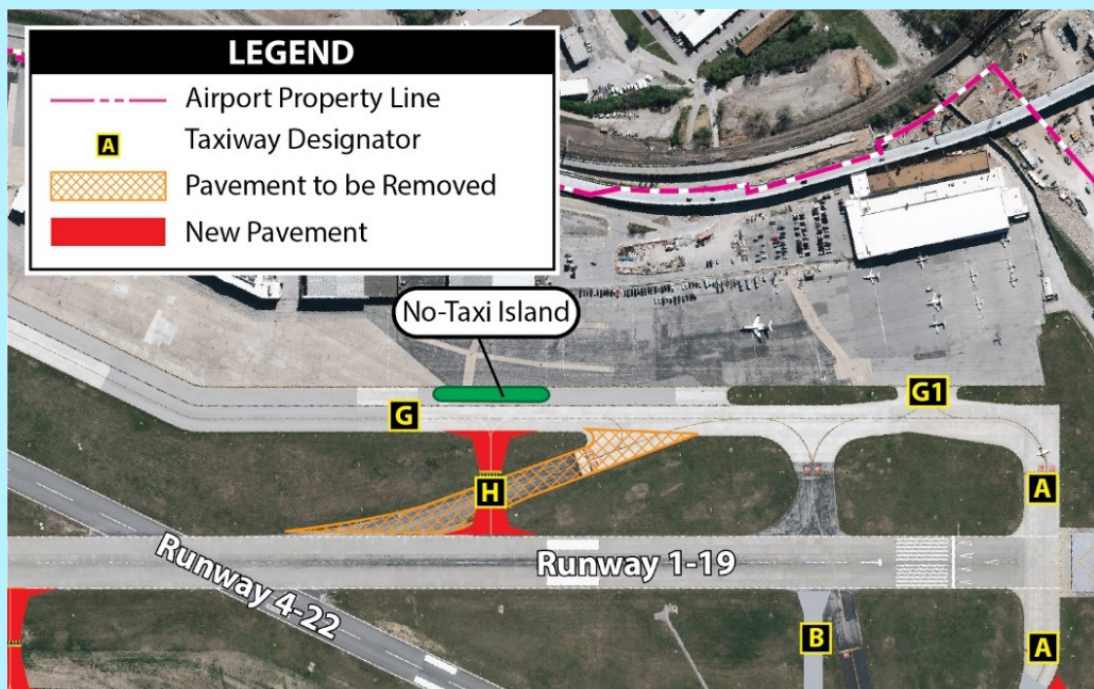
ALTERNATIVES 1 & 2

In this alternative, existing Taxiway H pavement is proposed to be removed and a new right-angle connector would be constructed between Runway 1-19 and Taxiway G. Note that alternatives 1 and 2 are the same in the master plan, therefore the pros and cons apply to both.

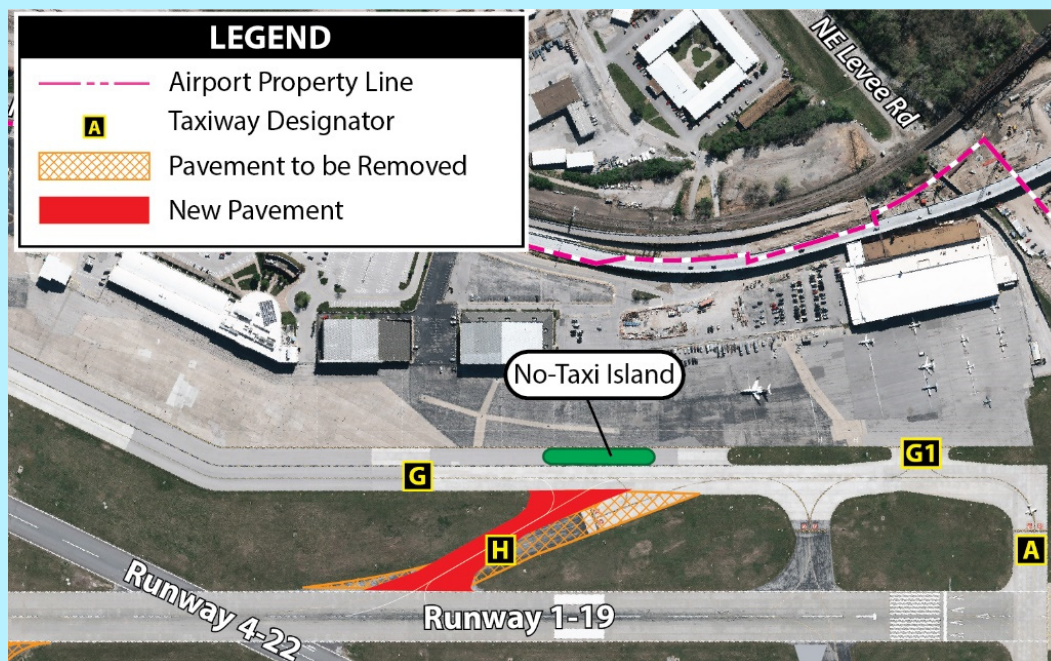
ALTERNATIVE 3

When it is time for Taxiway H to be reconstructed due to normal use, Taxiway H would be reconstructed at the standard 30-degree angle.

- Existing condition is non-standard because it's a 20-degree angle and not 30-degrees.

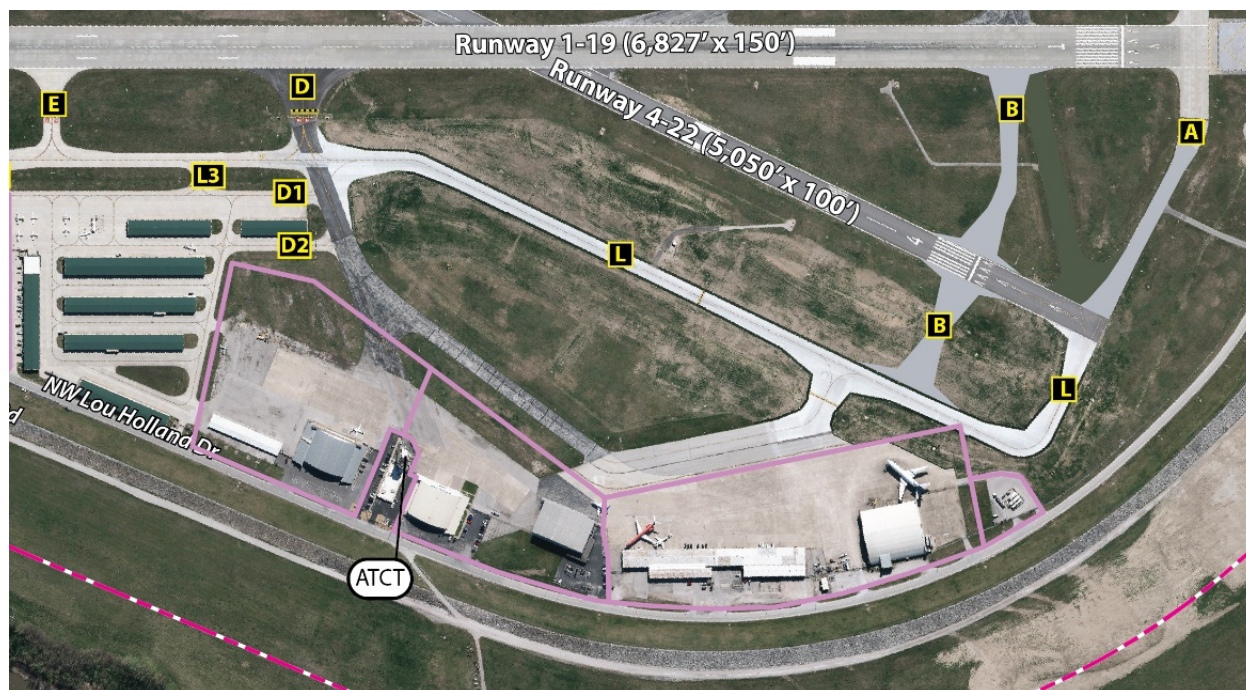
CURRENT CONDITIONS

The analysis for the southwest landside options is based on the current ATCT location to determine if proposed alternatives would interfere with the tower controller's line of sight. Each analysis is based on a cab eye level of 72 feet, with assumed hangar heights ranging from 20 feet (T-hangar) to 65 feet (a 200-foot by 200-foot conventional hangar).

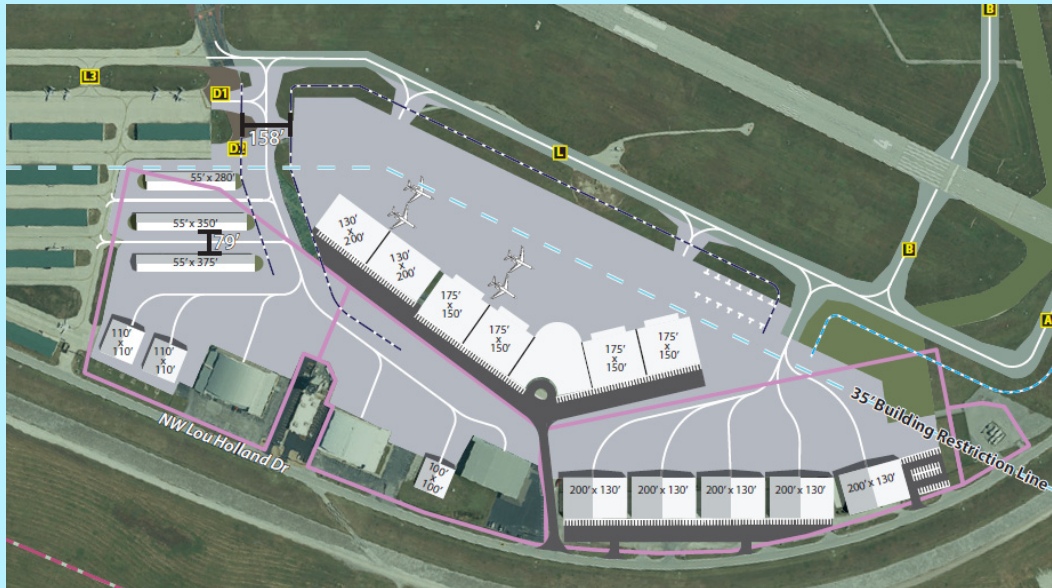
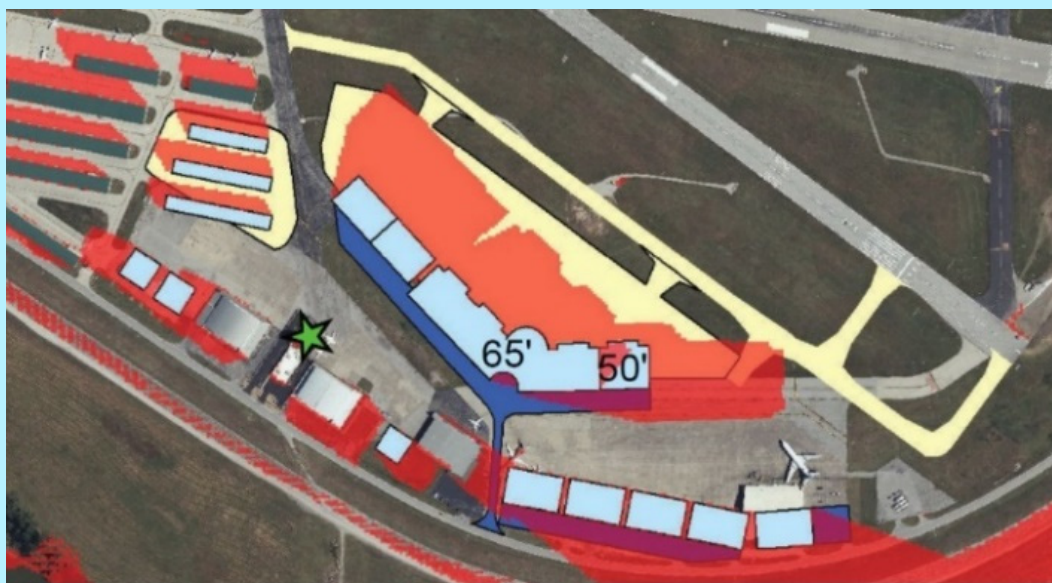
ALTERNATIVE 4

- The parking lot extends along the west edge of the lease line before the hangars. This layout locates the hangars as far back to the west as possible to maximize control tower sightlines.
- The access road is extended from Lou Holland Drive adjacent to Hangar 8B. This location is along the current lease line, which limits separating facilities.

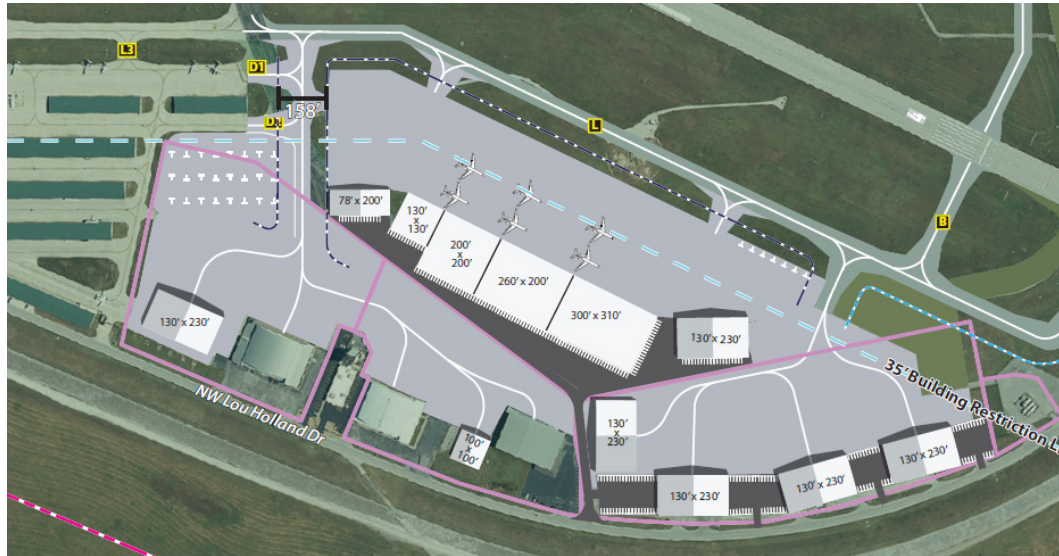
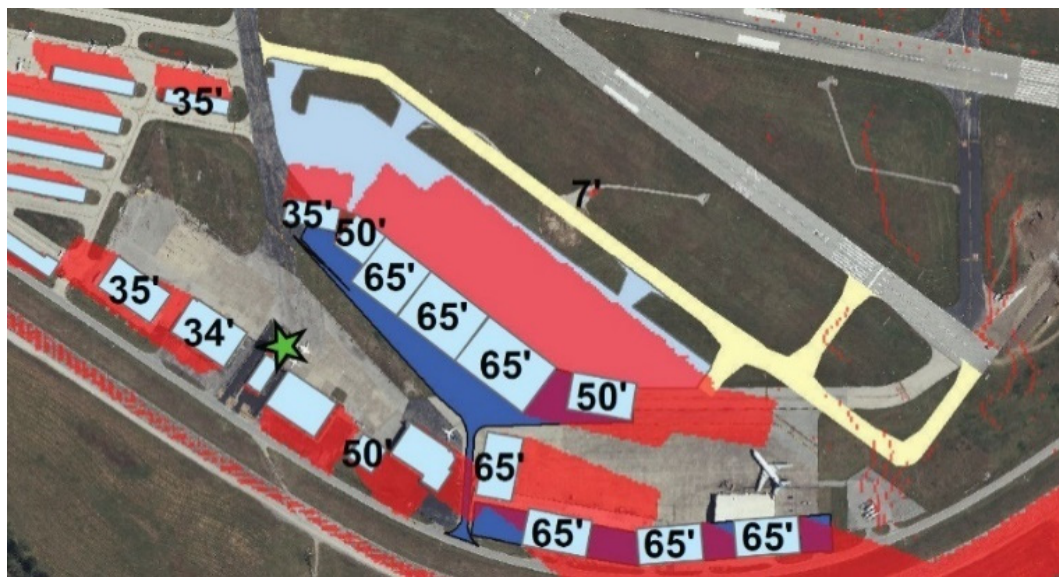
ALTERNATIVE 5

- This layout locates the hangars as far back to the west as possible to maximize control tower sightlines.
- The entirety of Taxiway L and the TOFA are visible to ATCT staff providing a clear line of sight and no constraints.

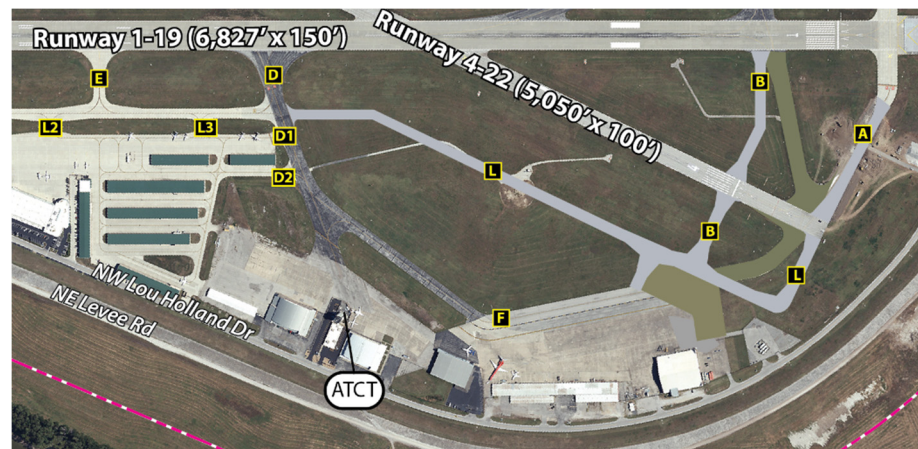
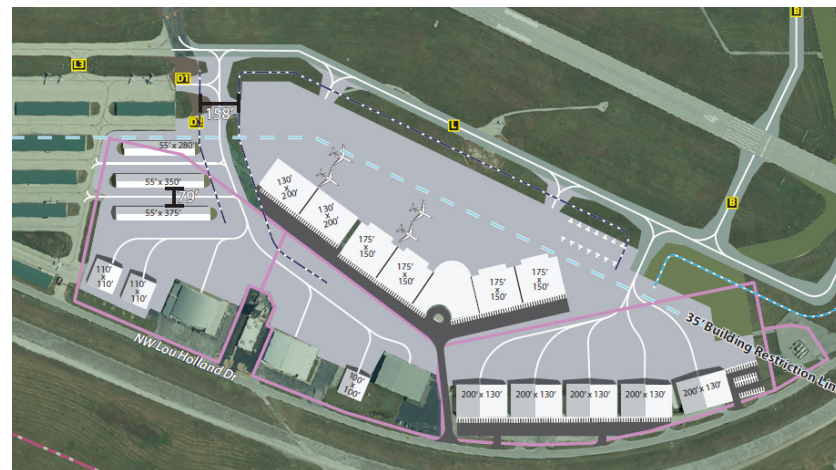
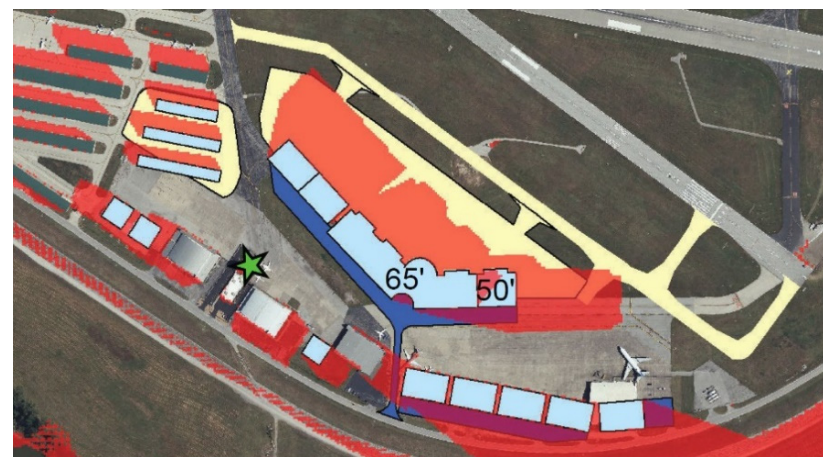
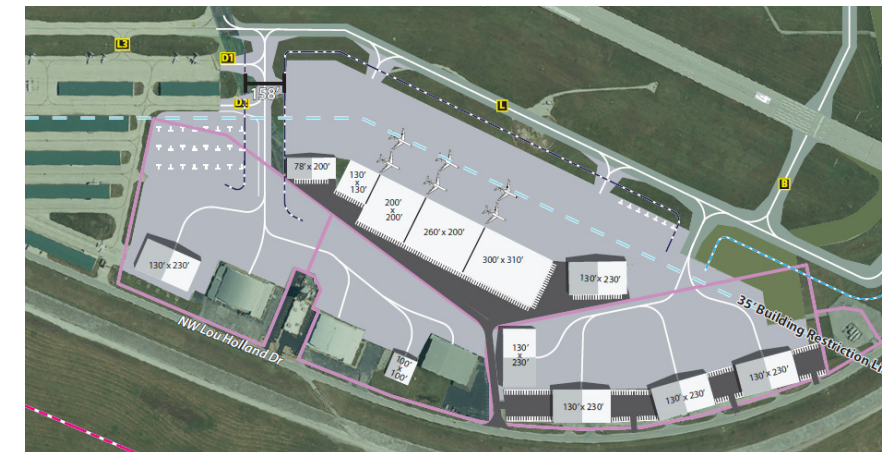
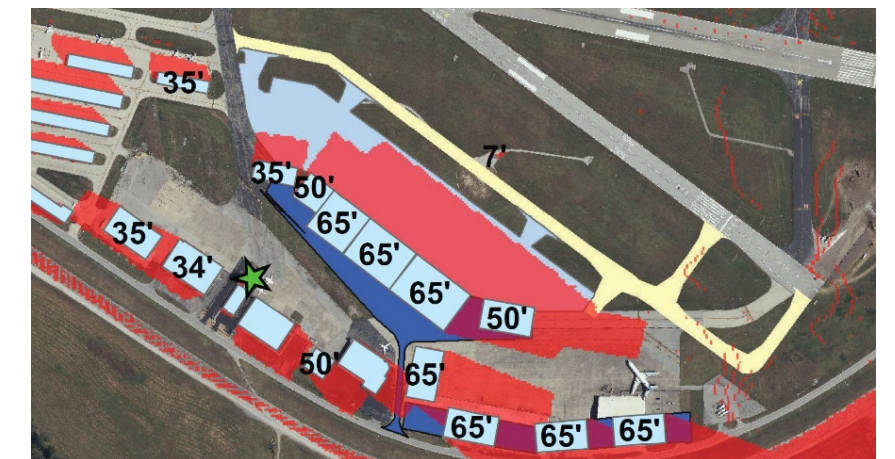
Element	Brief Description	Safety Concern(s)	Alternative 4	Alternative 5
Southwest Landside Alternatives Constrained by Existing Lease Lines	<p>This analysis is based on the current ATCT location to determine if the alternatives would interfere with the tower controller's line of sight.</p> <p>Each analysis is based on a cab eye level of 72 feet, with assumed hangar heights ranging from 20 feet (T-hangar) to 65 feet (200-foot by 200-foot conventional hangar).</p>	<p>Areas shaded in red are locations that would not be visible from the cab to the ground. The viewshed analysis for each southwest landside alternative is shown in the second figure of each alternative.</p> <p>Additionally, the existing Taxiway F will no longer serve as a taxiway under FAA ATCT control and will be separated by a roadway that enters the area from Lou Holland Drive.</p>	<ol style="list-style-type: none"> This is the first of two alternatives that generally preserve the existing lease lines in the southwest quadrant. This alternative considers several large conventional hangars that might be typical of an FBO complex. The hangars are large enough to house the largest business jets and potentially larger commercial type aircraft used for charter purposes. An access road is extended from Lou Holland Drive adjacent to Hangar 8B. This location is along the current lease line, which limits separating facilities. The access road extends to the 26-acre parcel that is currently unleased. The parking lot extends along the west edge of the lease line before the hangars. This layout attempts to locate the hangars as far back to the west as possible to maximize control tower sightlines. This alternative shows additional hangar development on parcels that are currently leased. Additional T-hangars are shown in proximity to the existing T-hangars. The existing shade hangar is shown to be replaced with two medium-sized box hangars. The south area is shown to be completely redeveloped with a series of conventional hangars. 	<ol style="list-style-type: none"> This is a variation of Landside Alternative 4 in which the centrally located hangars are more linearly oriented. There are a variety of hangar sizes; however, all are larger hangars that are typical for FBO services, bulk storage, or maintenance activities. The access road extends adjacent to Hangar 8B again along the existing parcel line. A development scenario is also shown for those areas that are currently under lease. On the south side of the new access road is redevelopment with four large conventional hangars. On the north side of the access road, the shade hangar is replaced with a conventional hangar and one other box hangar is shown to fill in an undeveloped area next to the AirShare hangar. The area next to the existing T-hangars is shown with a tiedown apron.

- Alternatives #1, #2, and #3 were not considered due to participant consensus that existing lease lines were to be maintained.
- Line of sight (viewshed review) was the most critical decision factor for alternative selection.
- Loss of Taxiway F as the primary taxi route into the area is managed by the implementation of Taxiway L as a replacement alternative.

- Taxiway L will replace Taxiway F as the primary taxiway route to the runways; Taxiway L was intended to replace Taxiway F; the Airport had not planned for Taxiway L to be an additional taxiway option. Consideration should be given to naming the new proposed taxiway “stubs” from the apron with a taxiway designation for ATCT and pilot coordination for arrivals and departures.
